Richland County Facility Assessment

September 4, 2024

OBJECTIVE FACILITY ASSESSMENT

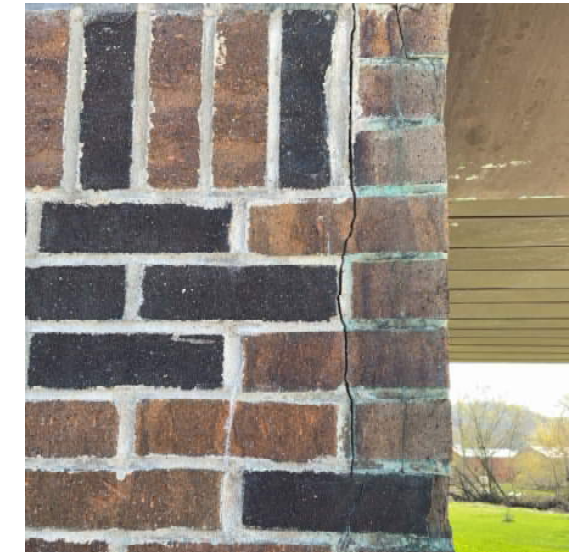
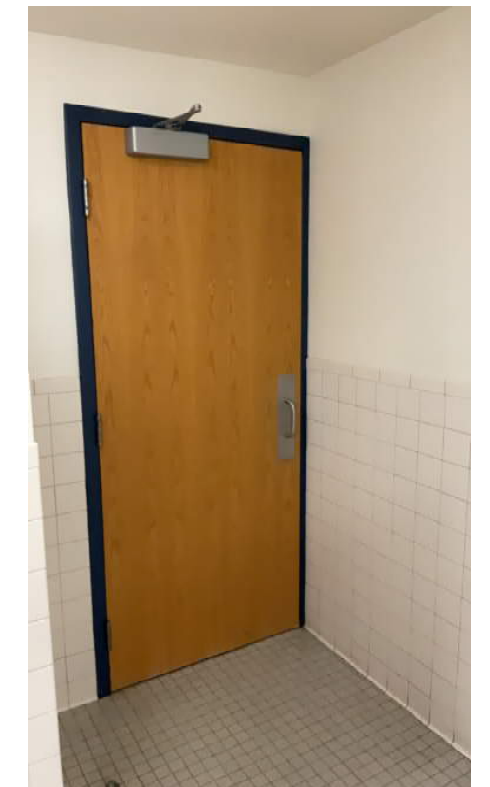
Building B – Arts & Education Building

- Building still original vintage.
- Finish materials dated and past life expectancy.
- Accessibility clearance issues throughout entire building.
- All windows are original 1966 construction, single pane glass.
- Mechanical AHUs replaced with residential furnaces.
- A/C condensing unit past end of life.
- Flooring delaminating apart from concrete slab.
- High likelihood of ACM in flooring, adhesives, sealants and pipe insulation.
- Exterior brick in need of tuckpointing.
- Structural layout and mix of structural systems makes it challenged for alteration.
- 62 total assets collected
- \$632k Renewal Cost
- \$4.2M Replacement cost

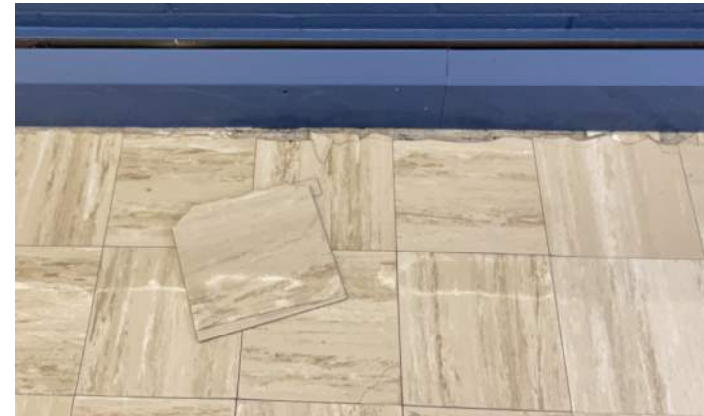
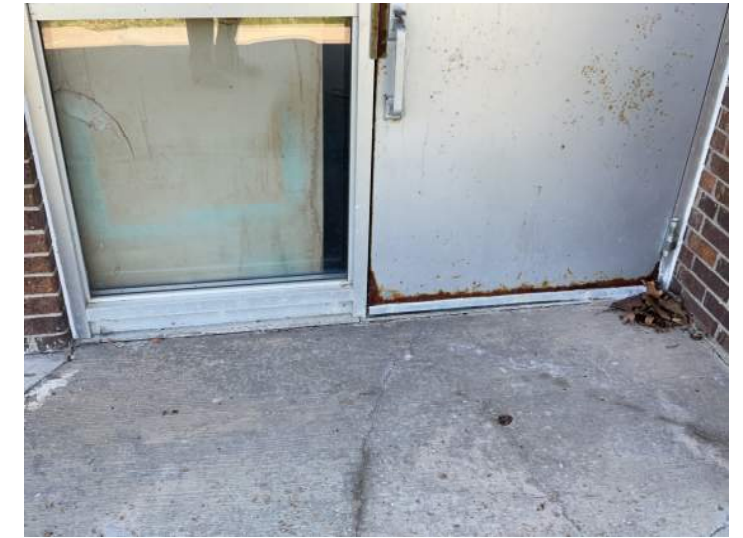
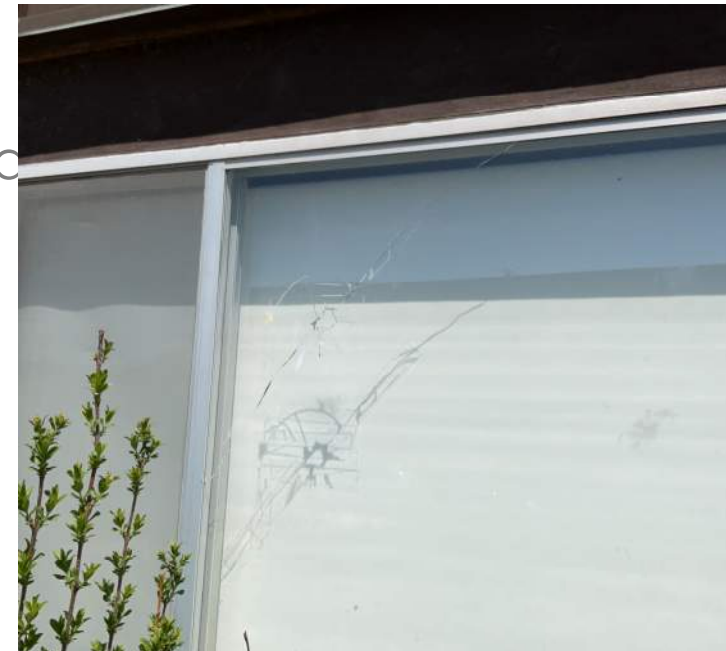
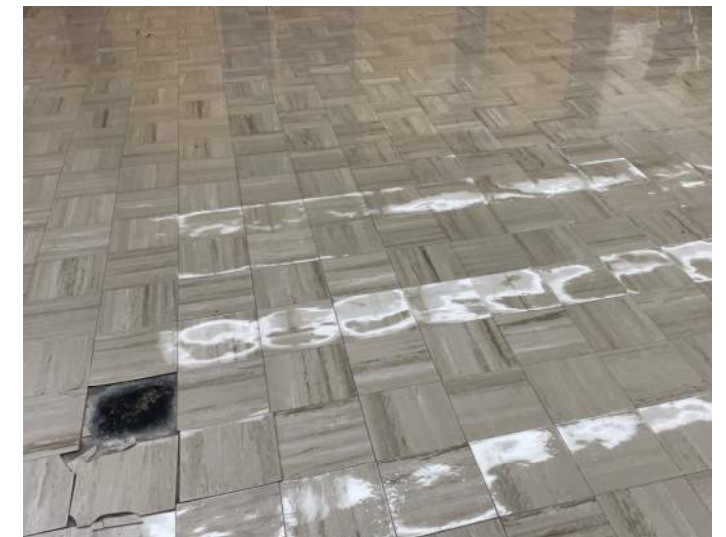
Building C – Library Building

- Building is of original 1966 vintage.
- Very superficial upgrades made to interior materials.
- Restrooms have major accessibility clearance issues throughout entire building. Addition needed to accommodate.
- All windows are original single pane sliders.
- Mechanical AHUs replaced with residential furnaces.
- A/C condensing unit and humidification system in need of replacement..
- Carpeting and flooring tile underneath in dire condition.
- High likely hood of ACM in flooring, adhesives, sealants and pipe insulation throughout building.
- Exterior brick, sealants, and windows in need of immediate attention.
- 83 total assets collected.
- \$1.17 M Renewal Cost
- \$6 M Replacement cost

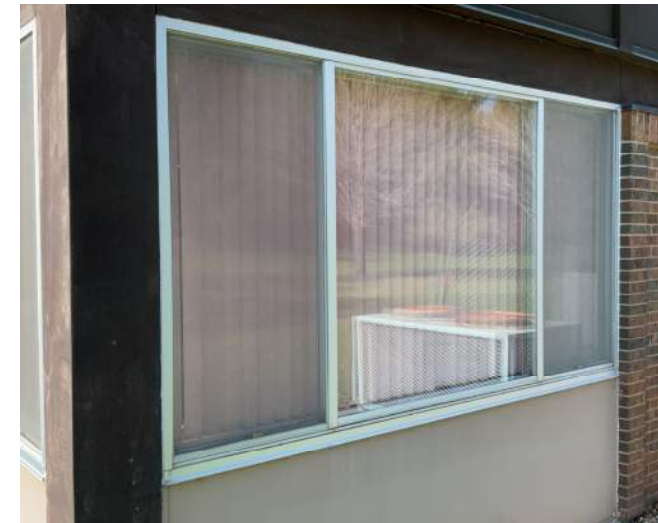
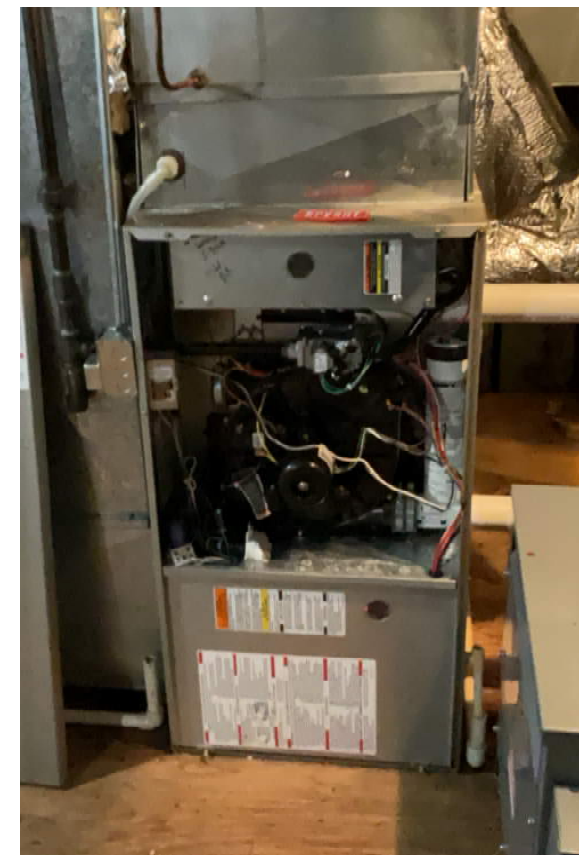
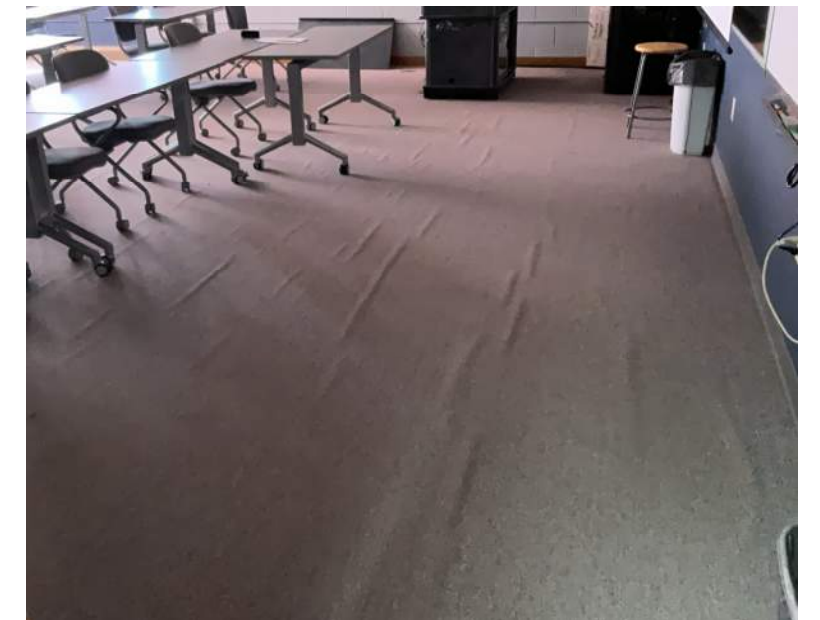
Building D – Melvill Hall – Administration Building

- 1998 Addition still functional.
- 1998 Addition addressed some accessibility problems for restrooms. Residual accessibility clearance and hardware issues remain.
- Most windows are original 1966 vintage.
- Mechanical AHUs nearing replacement.
- High likelihood of ACM in Original Building flooring, adhesives, sealants and pipe insulation.
- Courtyard in Original building both a functional and operational liability.
- Any sort of reuse would require significant floor plan modifications. Offices are undersized by today's standards.
- 113 total assets collected
- \$739.1k Renewal Cost
- \$7.95M Replacement cost

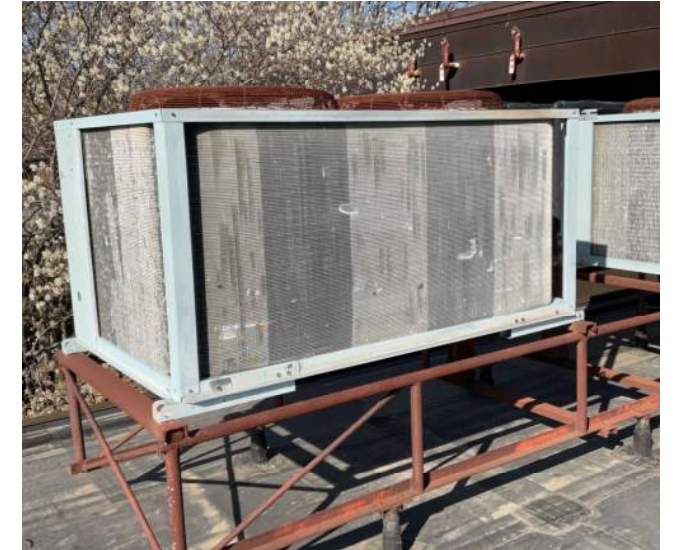
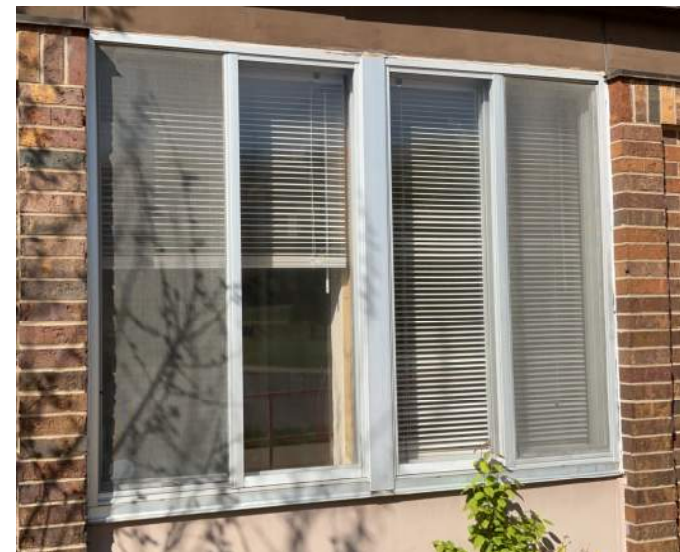
Building E – Cafeteria & Theater Building

- Building still original vintage.
- Materials in original structure partially upgraded.
- Accessibility issues throughout entire building, requiring major building renovations to remedy.
- All windows are original 1966 vintage.
- Mechanical AHUs are original.
- Boiler and water heater replaced.
- Water leaks in Music Room has caused damage to flooring.
- High likelihood of ACM in flooring, adhesives, sealants and pipe insulation.
- Kitchen and equipment in fair condition.
- Building has a very specific use, extremely limited options for reuse.
- 133 total assets collected.
- \$527.2k Renewal cost
- \$11.9M Replacement cost

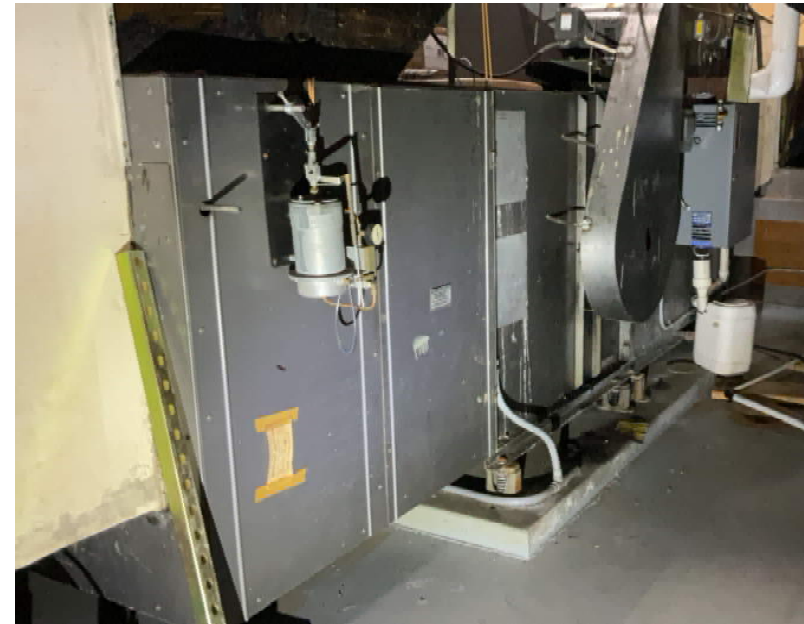
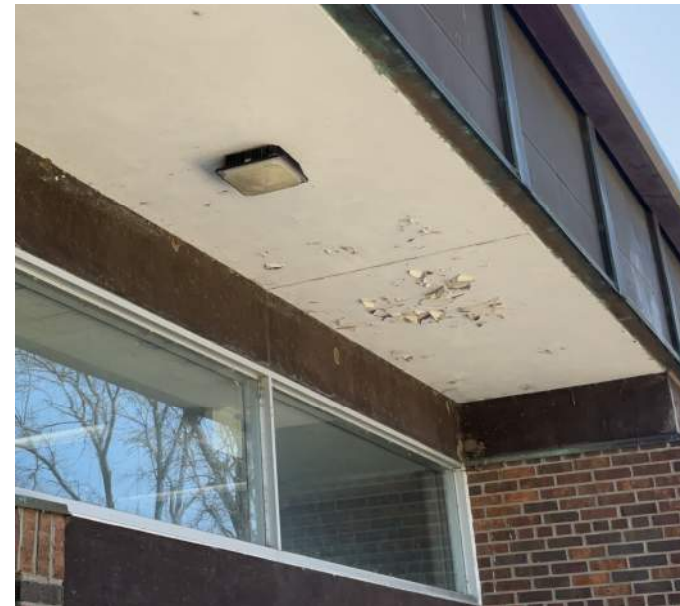
Building F – Gymnasium Building and Central Utility Plant

- Building originally designed for a highly specific use. Reuse options limited.
- Interior materials largely unchanged.
- Restroom accessibility clearance concerns at main lobby.
- Roof membrane and ballast pavers in need of replacement.
- Mechanical equipment original to building; all past their expected life .
- Athletic floor in decent condition.
- High likelihood of ACM in flooring, adhesives, sealants and pipe insulation.
- Significant deterioration at several doors.
- Would function well for athletic/training purposes.
- 99 total assets collected
- \$1.89M Renewal Cost
- \$9.7 M Replacement cost

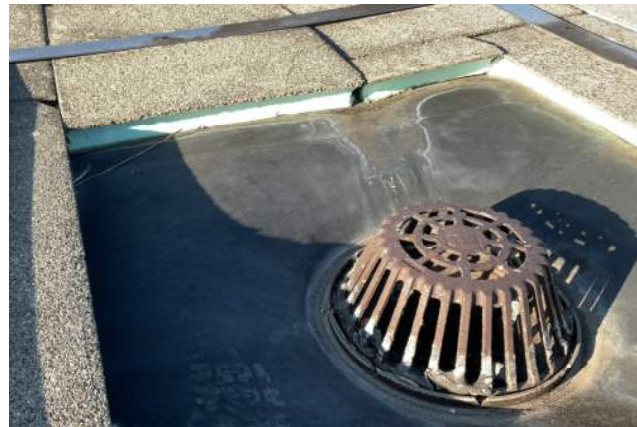
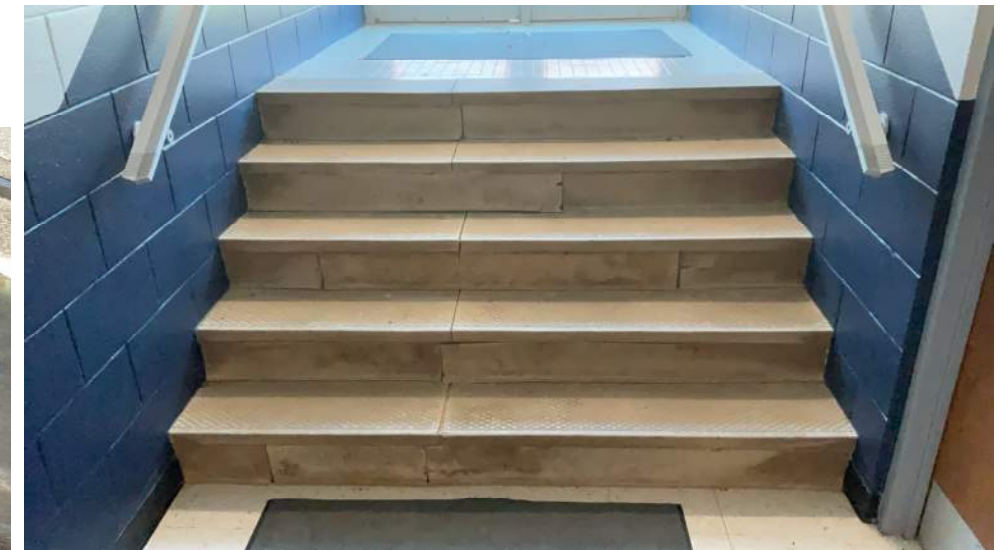
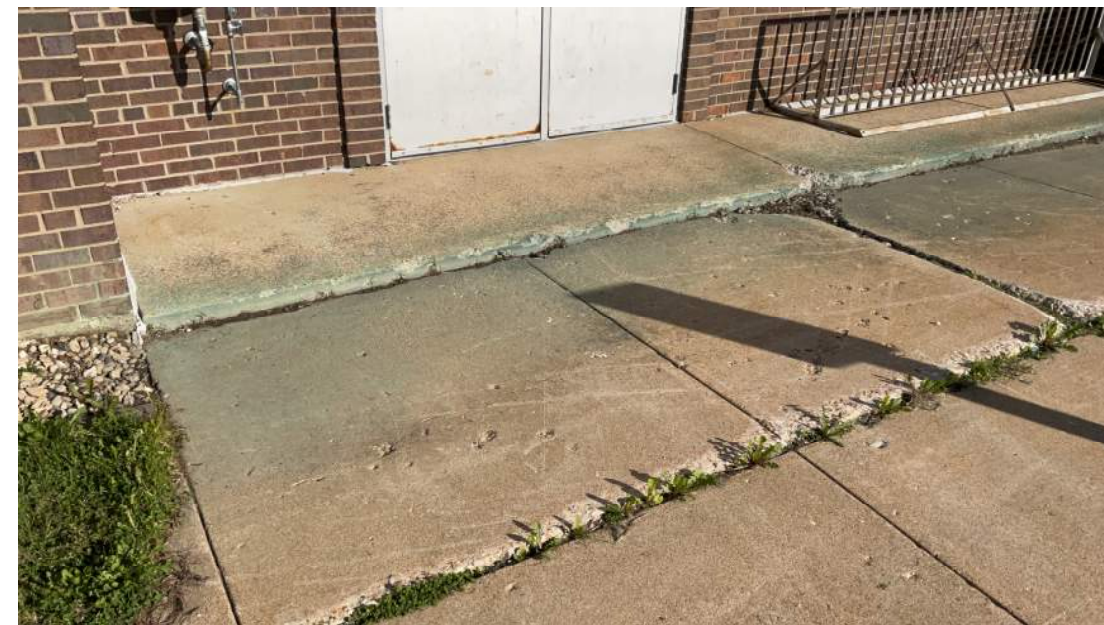
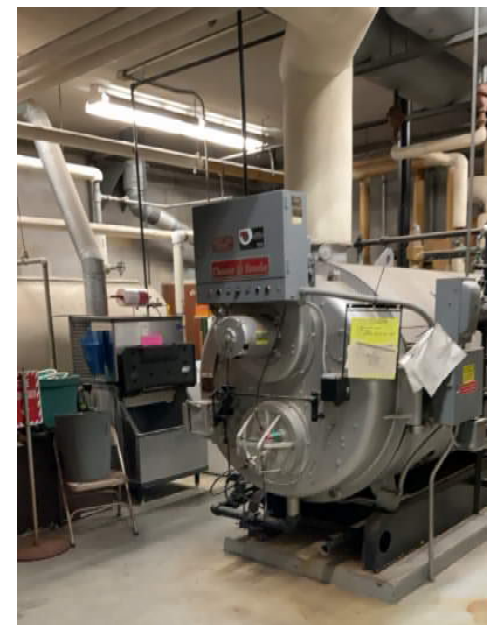
Health and Human Services Building

- Building originally designed as a supermarket.
- Interior materials sufficient but limited in resiliency.
- Accessibility clearances mostly not a concern.
- At-grade access points to building appropriate for clientele.
- Mechanical systems wholly inappropriate, consisting of 14 residential furnaces and condensing units.
- Organic departmental growth in the building has made functional efficiencies rather limited.
- Operational floor plan is highly inefficient.
- Exterior Insulation Finish System (EIFS) not a fiscally sustainable long-term solution.
- Building has great potential for better utilization through departmental realignment.
- 86 total assets collected
- \$444.8k Renewal Cost
- \$6M Replacement cost

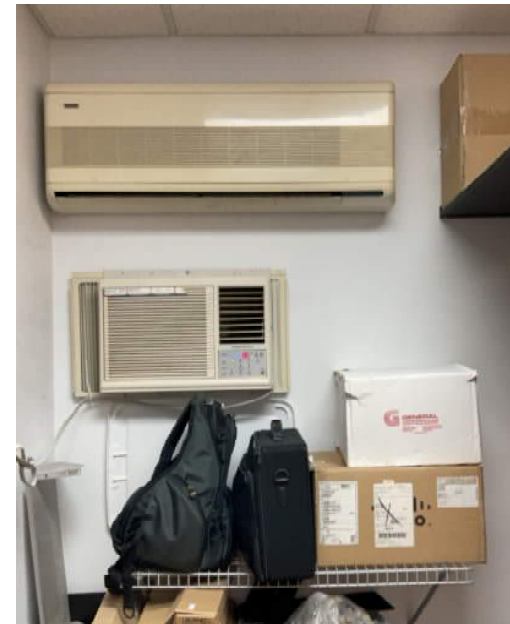
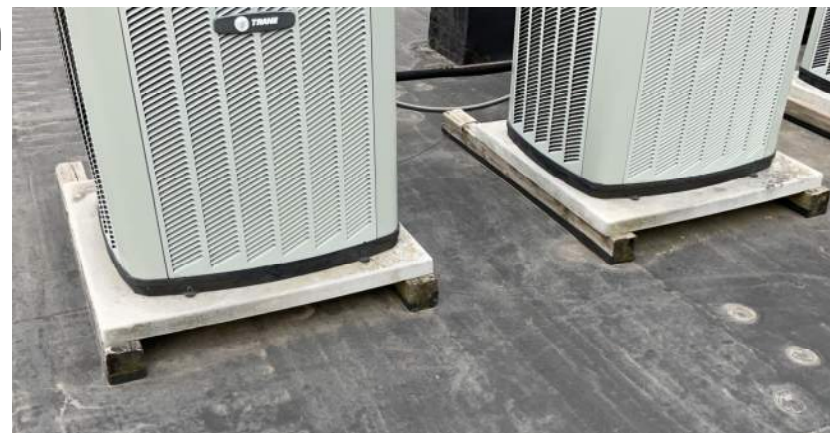
Courthouse Building

- Building, while not a historic landmark, has cultural significance to the county.
- Interior materials and finishes are unreplaceable.
- Major accessibility issues throughout entire building.
- Mechanical systems are extremely limited to physical infrastructure of building and in past replacement.
- Courtroom, while functional, has extreme legal operational deficiencies, and is not in alignment with Wisconsin Supreme Court Ruling 68 guidelines.
- Judicial related spaces lacking by nearly 10,000 SF.
- Roof system is 40 years old.
- Most windows at end-of-life expectancy.
- Office layouts are highly dysfunctional and inefficient.
- 174 total assets collected between Courthouse and Addition
- \$555k Renewal Cost / \$69.5M Replacement Cost
 - (includes Jail, Sheriff's Office & Administration)

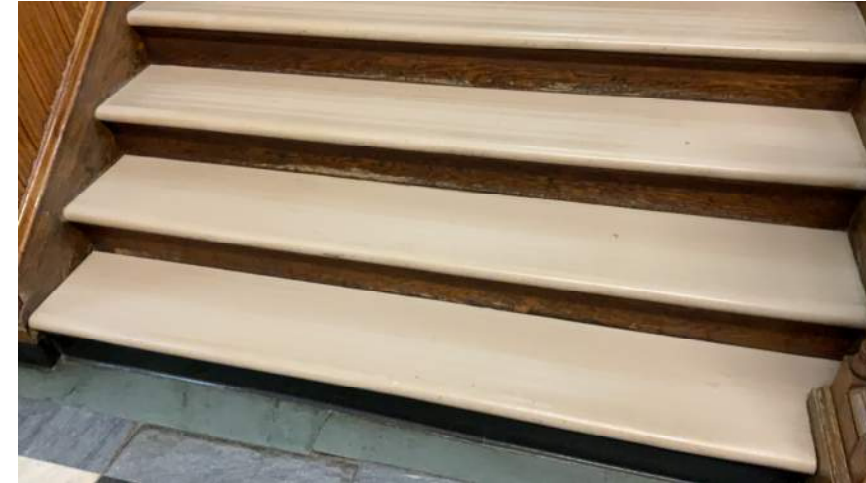
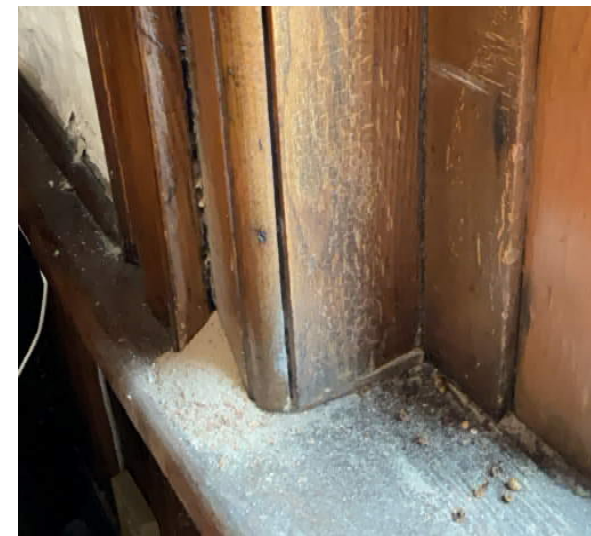
Jail and Administrative Office Addition

- Building originally built in 1982. Connected then Sheriff's Office to Courthouse. Provided elevator, then compliant restrooms and ramping to the differing floor levels between the three buildings
- Sheriff's Office functional, but disjointed and inefficient due to historic building constraints.
- Restrooms do not comply with accessibility requirements.
- Original design of Jail has become a limitation for RCSO to remain fully operationally compliant with current WI DOC 350 statutes. (Jail is spatially deficient by roughly 55,000 SF)
- Mechanical systems past life expectancy, and not up to mission critical standards.
- Administrative offices inefficient, and lacking roughly 2,400 SF.
- 174 total assets collected between Courthouse and Addition
- \$555k Renewal Cost / \$69.5M Replacement Cost
