NOTICE OF MEETING

Facility Condition Assessment Dashboard

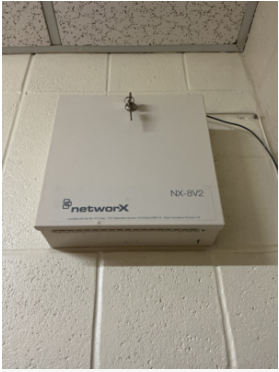
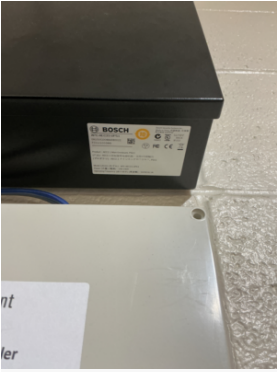
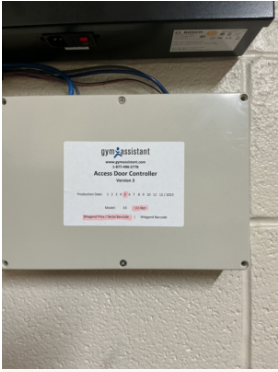
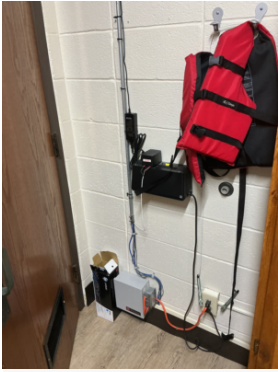
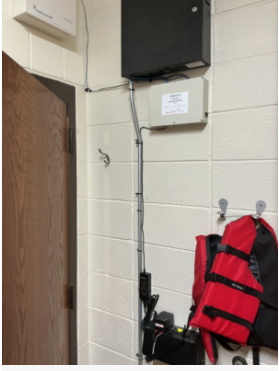
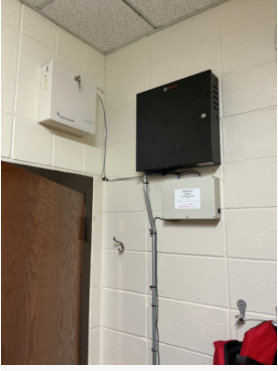
Access control system - Symon's Center

July 7, 2025	July 7, 2025		
Category: <i>! Electrical</i>		Size:	
Type:		Installation Date:	
Manufacturer: <i>Bosch /gym assistant</i>		Observed Remaining Life: <i>8</i>	
Model:		Condition: <i>Fair</i>	
Serial Number:		Cost:

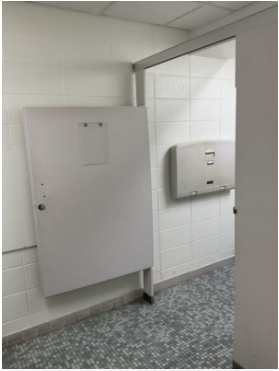
[ADA restroom - Symon's Center](#)

<p>July 21, 2025</p>		
Category: <i>! Accessibility</i>		Size:	
Type:		Installation Date:	
Manufacturer:		Observed Remaining Life: 15	
Model:		Condition: <i>Good</i>	
Serial Number:		Cost:

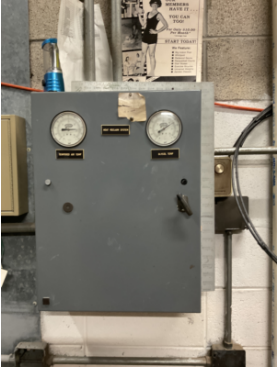
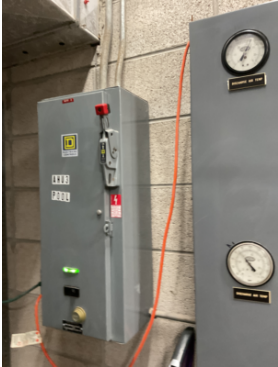
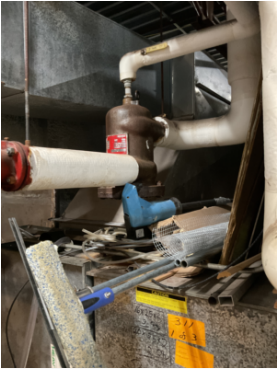
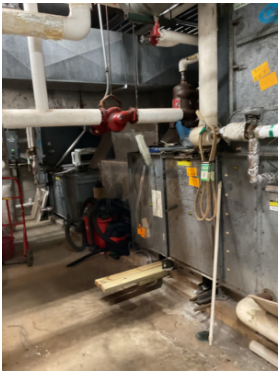
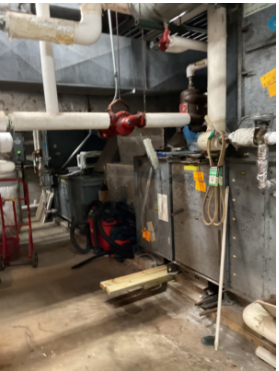
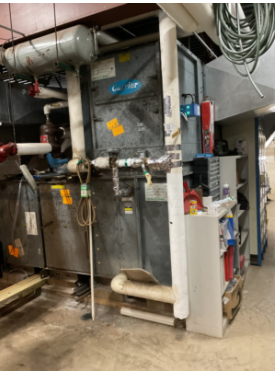
<u>Air handling unit - Symon's Center</u>			
  <p>July 1, 2025</p>

<p>July 1, 2025</p>
Category: <i>! Mechanical</i>		Size:	
Type: <i>Air Handling Unit</i>		Installation Date:	
Manufacturer:		Observed Remaining Life: <i>0</i>	
Model:		Condition: <i>Very Poor</i>	
Serial Number:		Cost: <i>\$13005</i>

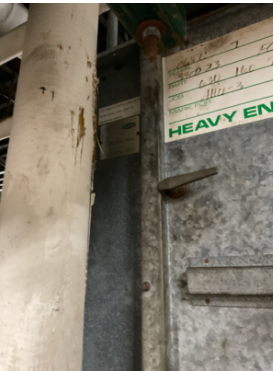
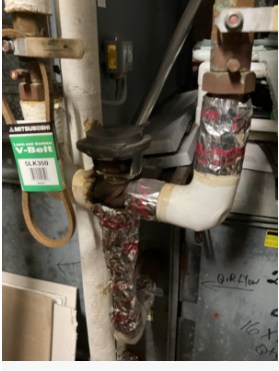
Air handling unit - Symon's Center

The HVAC systems serving the building addition are of commercial quality. There are three basic systems serving this building, air handling units, residential furnaces, and a hot water boiler system. Please note that this building is not provided with air conditioning except for a newer gym area on the west side of the complex. The air handling units are beyond their anticipated life expectancy. As this building is provided with a pool, a dedicated pool dehumidification unit should be provided. With current HVAC system components, it is possible that a number of the air handling units could be consolidated and be provided with VAV operation for energy savings opportunities. There are portions of this system which should be evaluated for potential replacement and/or upgrades. One particular item to note is the condition of the coils in the AHU ductwork. These coils are experiencing an excessive amount of corrosion. These coils and the ductwork immediately around the ductwork are likely to require replacement in the near future. The hot water boiler system provides all building heating needs. This system appears to be around half-way through its anticipated life. This style of boiler typically has a life expectancy of around 25 years. These particular boilers were installed around 2014. To continue operating without issue, there are components within this system which will require replacement and/or upgrades. Lastly, the boilers should be inspected by a qualified boiler inspector to determine the overall condition of the boilers and their suitability for continued use. The temperature controls serving this building are antiquated and are over-due for an upgrade. The biggest risk of failure in this building is the temperature control system.

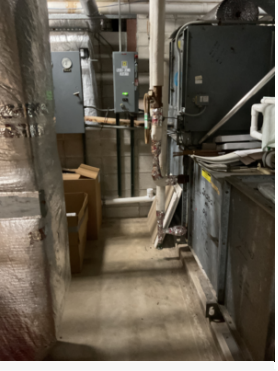
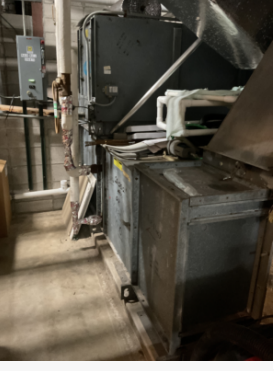
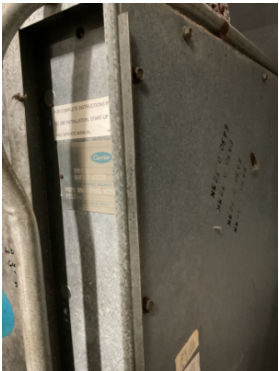
<p>July 1, 2025</p>		
Category: <i>! Mechanical</i>		Size:	
Type: <i>Air Handling Unit</i>		Installation Date:	
Manufacturer:		Observed Remaining Life: <i>0</i>	
Model:		Condition: <i>Very Poor</i>	
Serial Number:		Cost: <i>\$13005</i>

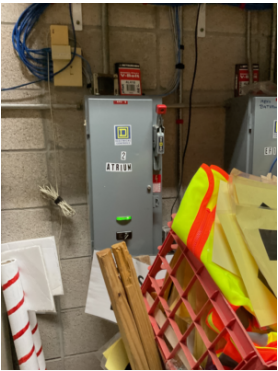
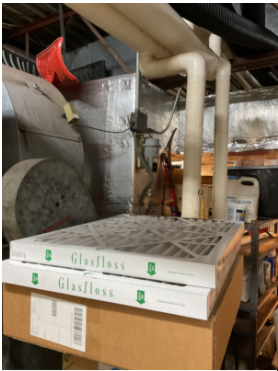
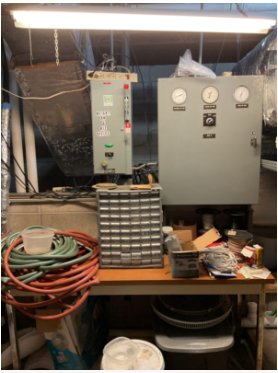
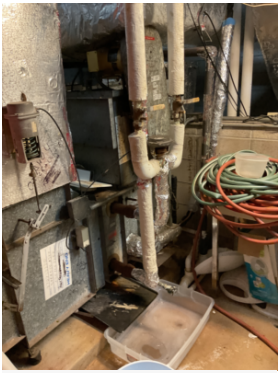
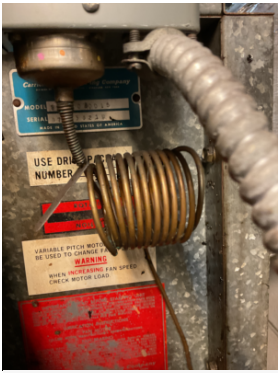
July 1, 2025	July 1, 2025	July 1, 2025	
Category: <i>! Mechanical</i>		Size:	
Type: <i>Air Handling Unit</i>		Installation Date:	
Manufacturer:		Observed Remaining Life: <i>0</i>	
Model:		Condition: <i>Very Poor</i>	
Serial Number:		Cost: <i>\$13005</i>

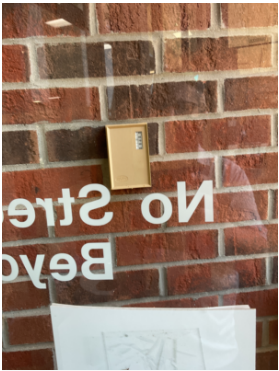
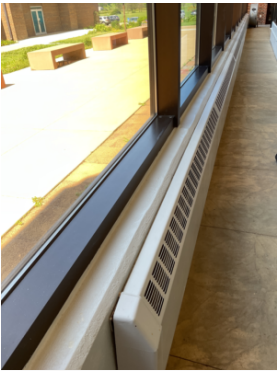
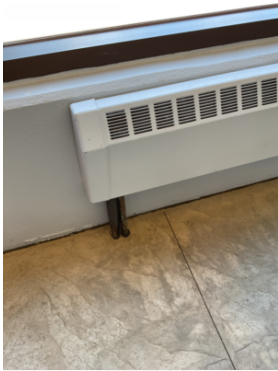
Baseboard radiation - Symon's Center

July 1, 2025	July 1, 2025	July 1, 2025	
Category: <i>! Mechanical</i>		Size:	
Type: <i>Coils</i>		Installation Date:	
Manufacturer:		Observed Remaining Life: <i>20</i>	
Model:		Condition: <i>Good</i>	
Serial Number:		Cost:

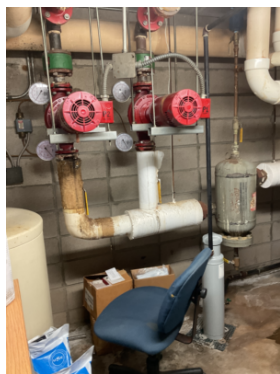
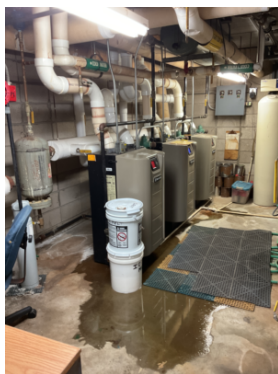
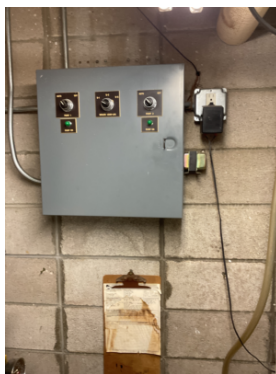
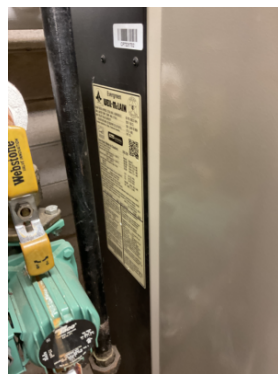
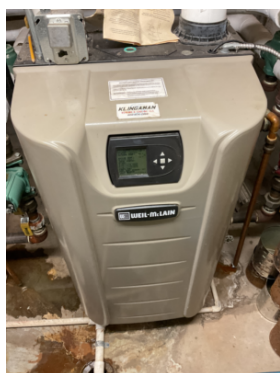
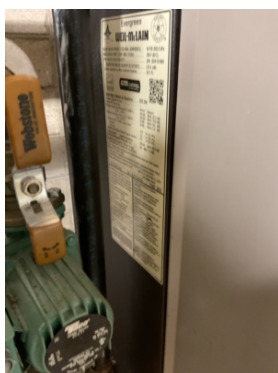
Boiler 2 - Symon's Center

Category: ! Mechanical

Observed Remaining Life: 10

Condition: Fair

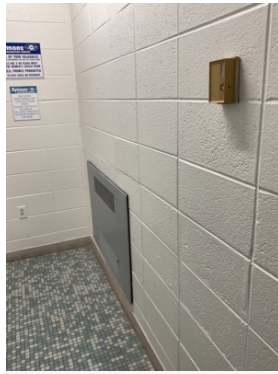
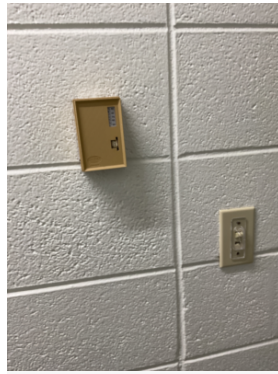
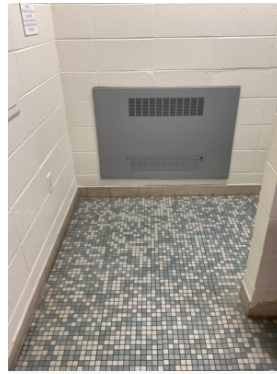
Cabinet Unit Heater - Symon's Center

Category: *! Mechanical*

Observed Remaining Life: *8*

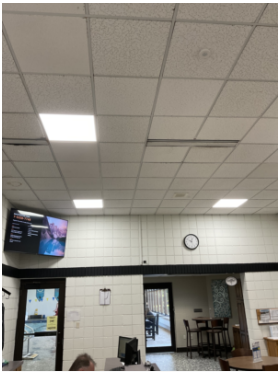
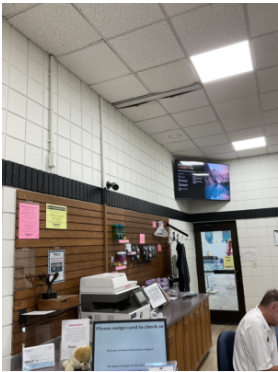
Ceiling - Symon's Center

The ceiling tiles, doors, and windows in this building are in fair to poor condition. Many of the ceiling grids and tiles are near the end of their useful life, replacement or selective maintenance of the existing ceiling grids and tiles is recommended. Many of the doors' hardware throughout the building have corroded and rusted away due to the high humidity levels in the building and high chlorine exposure. Therefore, the door's hardware, frames and doors itself will require replacement in the future. The steel lintel at the fitness studio's exterior door on the building's north side will also need to be replaced. We noticed the interior sills of the windows in the 1998 west addition are warping and believe they are the result of water infiltration. During our assessment we were unable to locate the sill flashing and think that potentially could be the cause of the water infiltration and warping of the sills. However, without updated window drawings that match the current conditions or further investigation we cannot be sure. There was also major rusting in the lintels and overhead flashings of these windows. Both the steel lintels and overhead flashings will require replacement for all the windows in the 1998 west addition. On the other hand, the exterior storefront windows on the building's east side were in fair condition and didn't show any of those deficiencies. However, the window's sill flashing seemed to be pitched back towards the interior side of the building which will just allow water into the building. We recommend a further investigation be conducted into all the windows mentioned above to verify the underlying cause of the windows issues and next best steps.

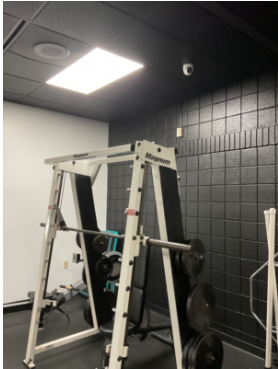
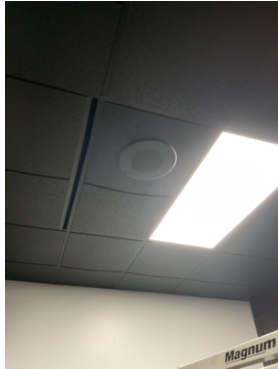
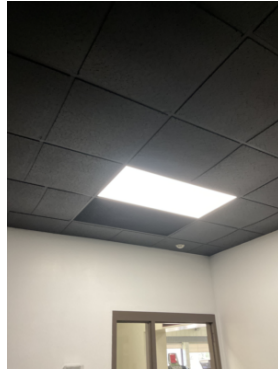
Ceiling - Symon's Center

<p>July 15, 2025</p>
Category: ! Building Interior		Size:	
Type: Ceilings		Installation Date:	
Manufacturer:		Observed Remaining Life: 5	
Model:		Condition: Fair	
Serial Number:		Cost:

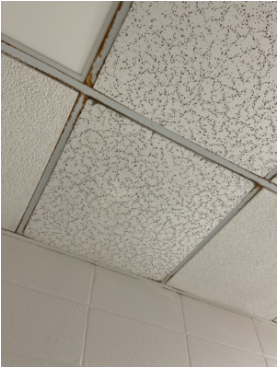
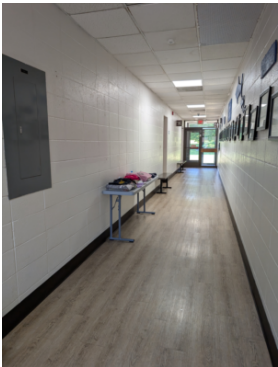
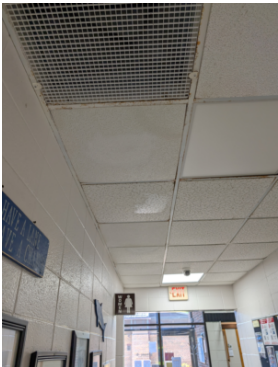
Ceiling - Symon's Center

<p>July 21, 2025</p>
Category: ! Building Interior		Size:	
Type:		Installation Date:	
Manufacturer:		Observed Remaining Life: 3	
Model:		Condition: Poor	
Serial Number:		Cost: \$3269.87

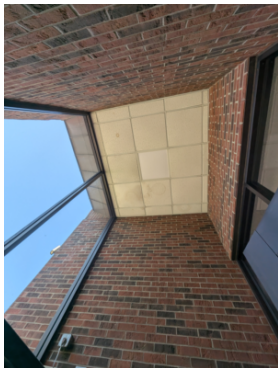
Ceiling - Symon's Center

Category: ! Building Interior

Observed Remaining Life: 5

Condition: Fair

Cost: \$430.71

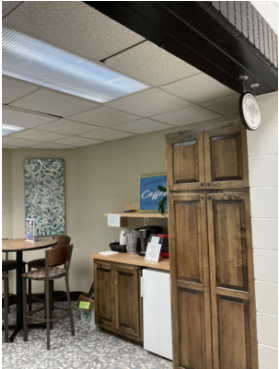
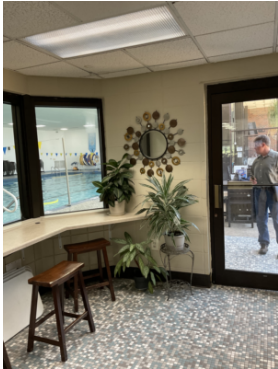
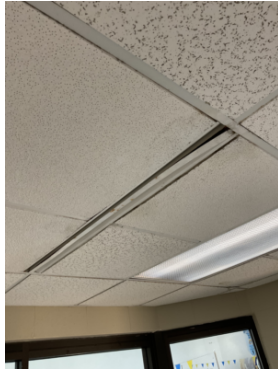
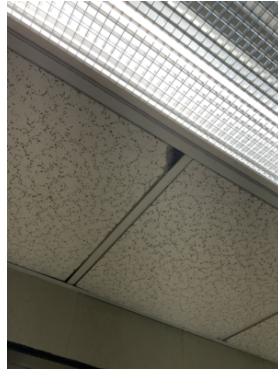
Ceiling - Symon's Center

<p>July 21, 2025</p>
Category: ! Building Interior		Size:	
Type:		Installation Date:	
Manufacturer:		Observed Remaining Life: 5	
Model:		Condition: Fair	
Serial Number:		Cost: \$1731.62

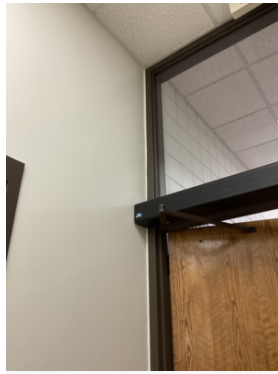
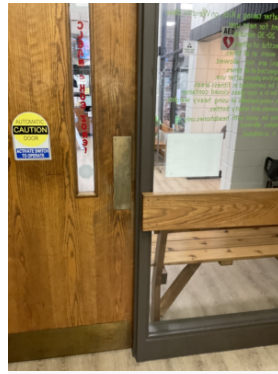
Door - Symon's Center

Category: ! Building Interior

Observed Remaining Life: 10

Condition: Fair

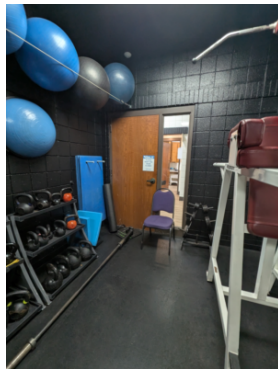
Door - Symon's Center

Category: ! Building Interior

Observed Remaining Life: 10

Condition: Good

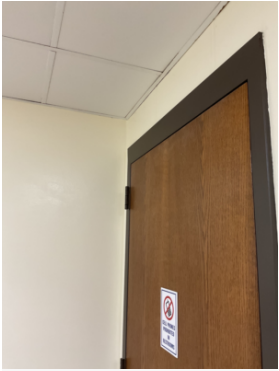
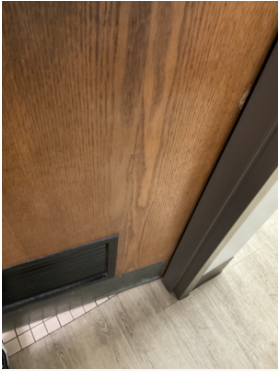
Door - Symon's Center

July 15, 2025	July 15, 2025		
Category: ! Building Interior		Size:	
Type:		Installation Date:	
Manufacturer:		Observed Remaining Life: 10	
Model:		Condition: Good	
Serial Number:		Cost: \$818

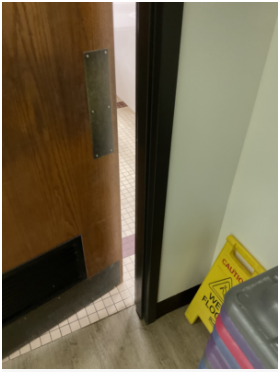
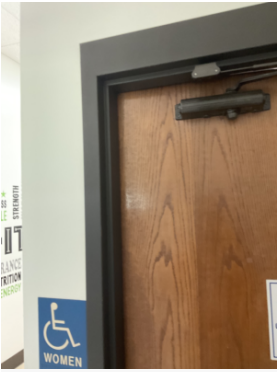
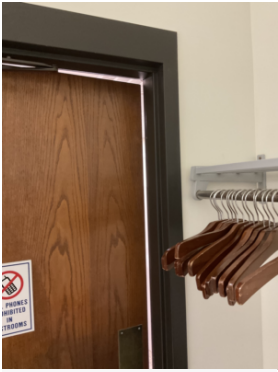
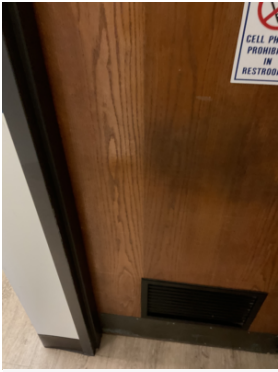
Door - Symon's Center

July 21, 2025	July 21, 2025	July 21, 2025	July 21, 2025
Category: ! Building Interior		Size:	
Type:		Installation Date:	
Manufacturer:		Observed Remaining Life: 10	
Model:		Condition: Good	
Serial Number:		Cost: \$818

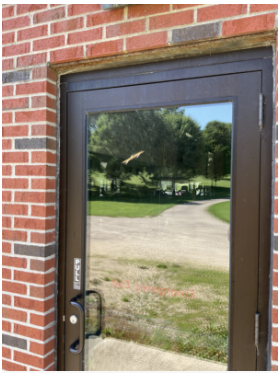
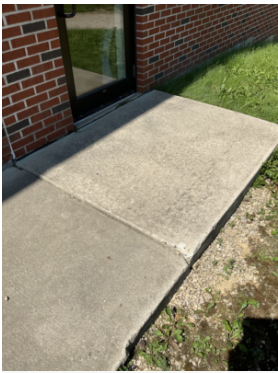
Door - Symon's Center

Category: ! Building Exterior

Observed Remaining Life: 5

Condition: Fair

Cost: \$3199.45

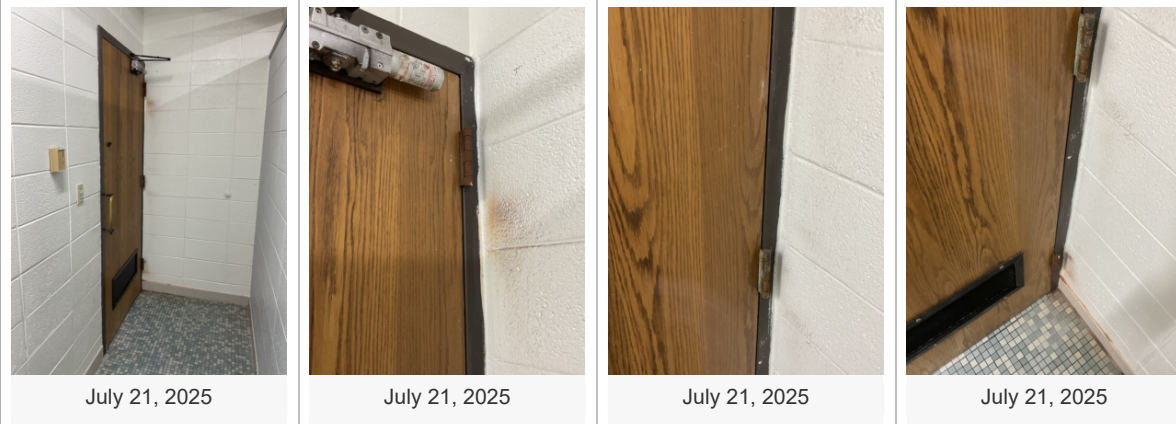
Door - Symon's Center

Category: ! Building Interior

Observed Remaining Life: 2

Condition: Poor

Cost: \$1420.50

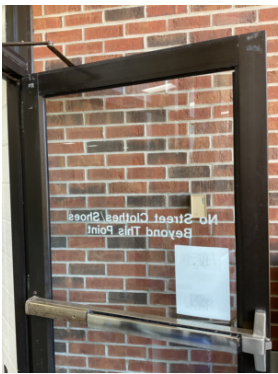
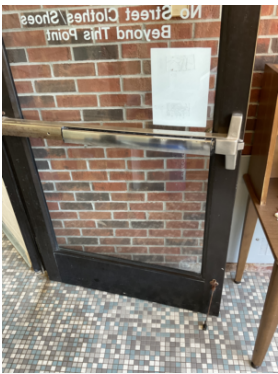
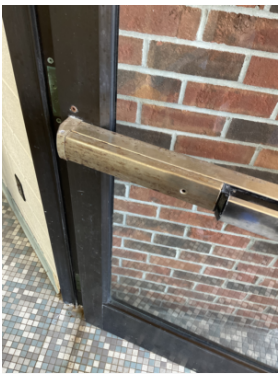
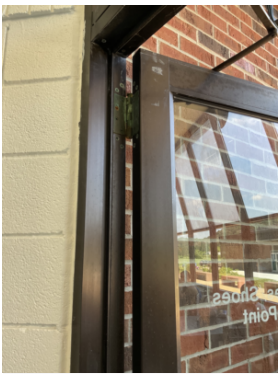
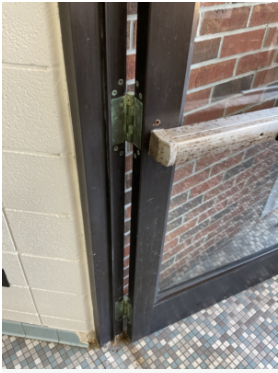
Door - Symon's Center

Category: ! Building Interior

Observed Remaining Life: 2

Condition: Poor

Cost: \$3801.45

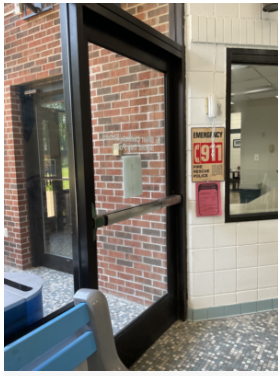
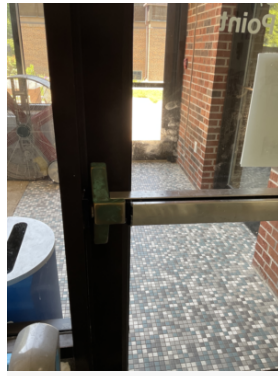
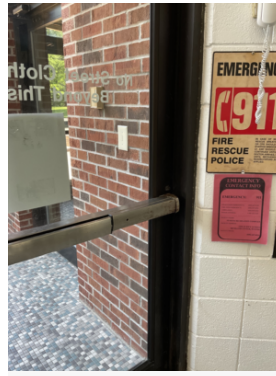
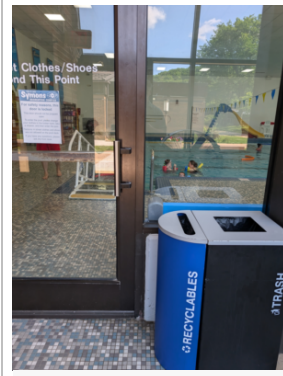
Door - Symon's Center

Category: ! Building Interior

Observed Remaining Life: 5

Condition: Fair

Cost: \$3801.45

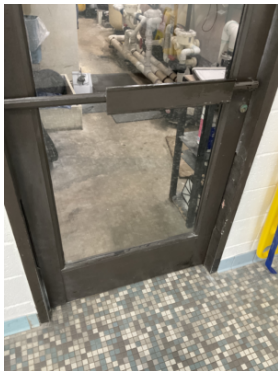
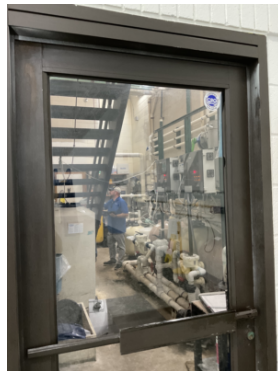
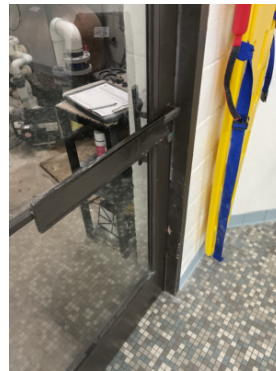
Door - Symon's Center

Category: ! Building Interior

Observed Remaining Life: 5

Condition: Fair

Cost: \$5141.45

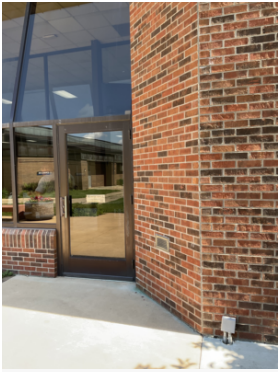
Door - Symon's Center

<p>July 17, 2025</p>			
Category: <i>! Building Exterior</i>		Size:	
Type: <i>Doors</i>		Installation Date:	
Manufacturer:		Observed Remaining Life: 10	
Model:		Condition: <i>Good</i>	
Serial Number:		Cost: \$3629.50

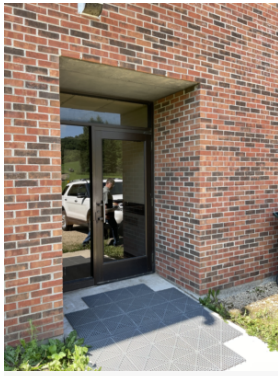
Door - Symon's Center

Category: ! Building Exterior

Observed Remaining Life: 10

Condition: Good

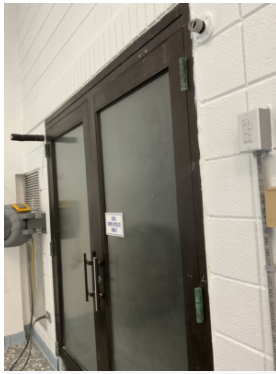
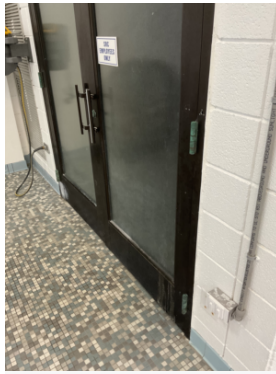
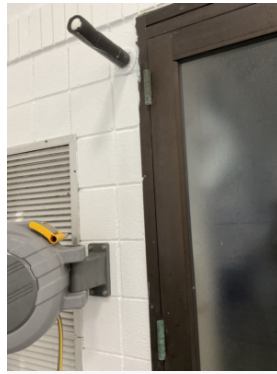
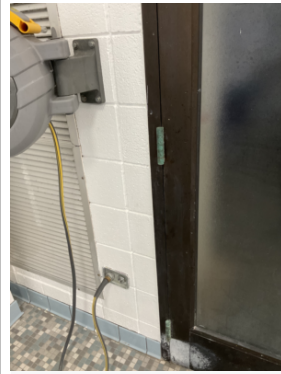
Doors - Symon's Center

Category: ! Building Interior

Observed Remaining Life: 2

Condition: Poor

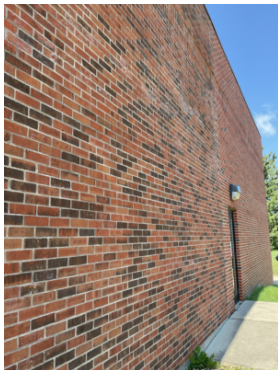
Exterior wall - Symon's Center

Category: ! Building Exterior

Observed Remaining Life: 2

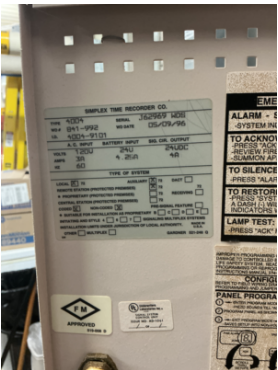
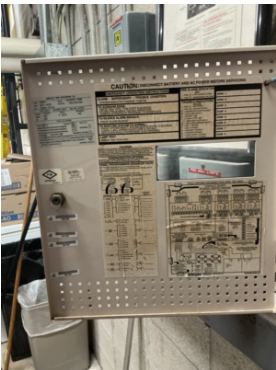
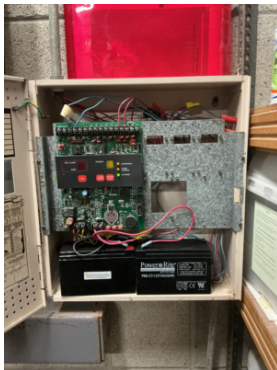
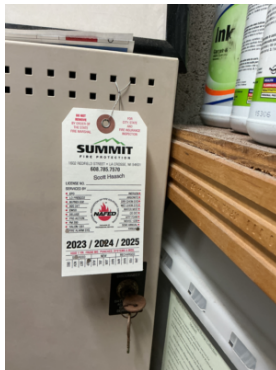
[Fire alarm control panel](#) - [Symon's Center](#)

<p>July 7, 2025</p>			
Category: ! Electrical	Size:		
Type:	Installation Date: 1998		
Manufacturer: Simplex	Observed Remaining Life: 8		
Model:	Condition: Fair		
Serial Number:	Cost: \$2839

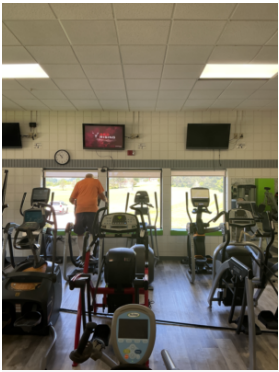
Fire alarm horn strobe - Symon's Center

<p>July 7, 2025</p>			
Category: ! Electrical	Size:		
Type:	Installation Date:		
Manufacturer: Simplex	Observed Remaining Life: 7		
Model:	Condition: Good		
Serial Number:	Cost:

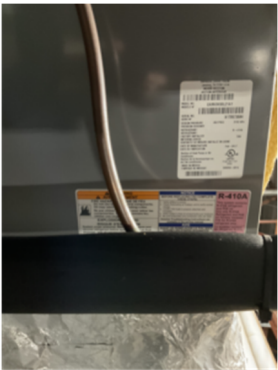
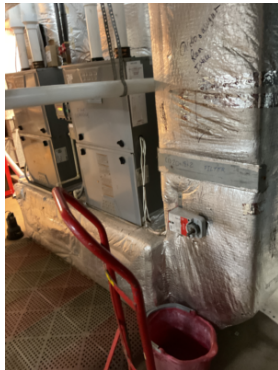
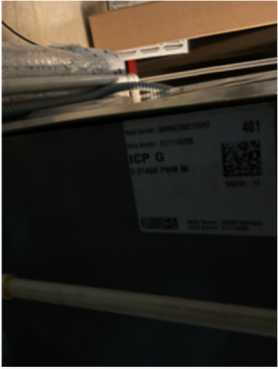
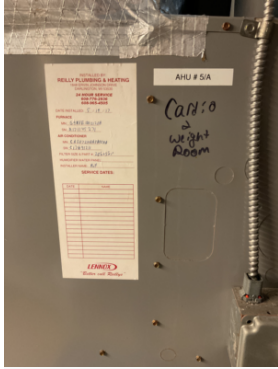
Furnaces - Symon's Center

<p>July 1, 2025</p>
Category: <i>! Mechanical</i>		Size:	
Type: <i>Furnace</i>		Installation Date:	
Manufacturer:		Observed Remaining Life: <i>7</i>	
Model:		Condition: <i>Very Poor</i>	
Serial Number:		Cost: <i>\$2180</i>

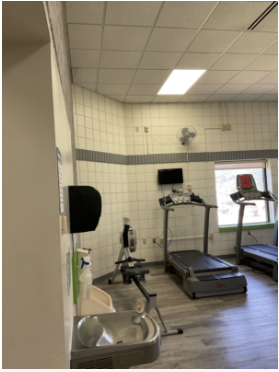
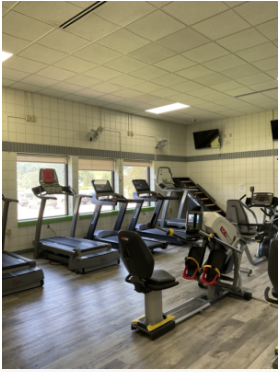
Gym Flooring - Symon's Center

<p>July 21, 2025</p>		
Category: <i>! Building Interior</i>		Size:	
Type: <i>Floor Finishes</i>		Installation Date:	
Manufacturer:		Observed Remaining Life: <i>20</i>	
Model:		Condition: <i>Good</i>	
Serial Number:		Cost:

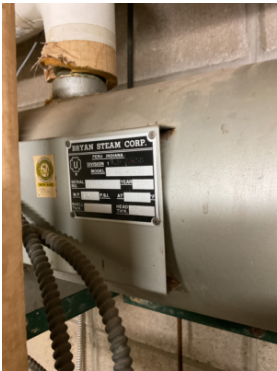
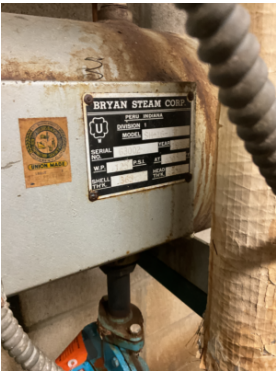
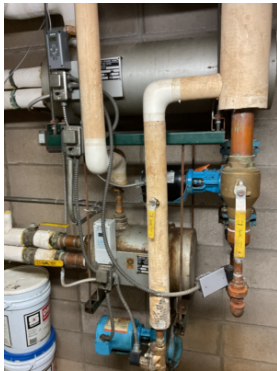
Heat exchangers - Symon's Center

<p>July 1, 2025</p>	
Category: <i>! Mechanical</i>		Size:	
Type: <i>Heat Exchangers</i>		Installation Date:	
Manufacturer:		Observed Remaining Life: <i>10</i>	
Model:		Condition: <i>Poor</i>	
Serial Number:		Cost: <i>\$5818</i>

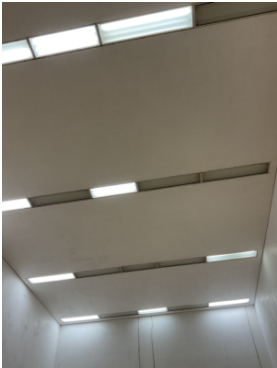
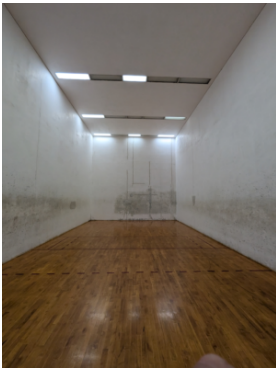
Lighting - Symon's Center

July 21, 2025	July 21, 2025		
Category: ! Building Interior		Size:	
Type: Lighting Quality		Installation Date:	
Manufacturer:		Observed Remaining Life: 2	
Model:		Condition: Poor	
Serial Number:		Cost: \$620

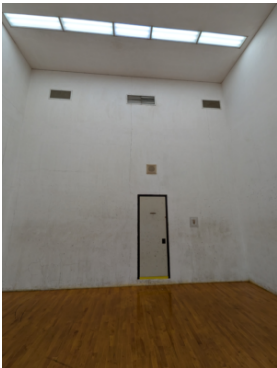
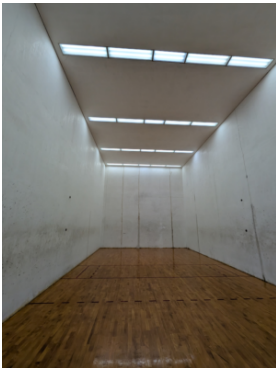
Lighting - Symon's Center

Category: <i>! Building Interior</i>	Size:
Type: <i>Lighting Quality</i>	Installation Date:
Manufacturer:	Observed Remaining Life: 7
Model:	Condition: <i>Good</i>
Serial Number:	Cost:

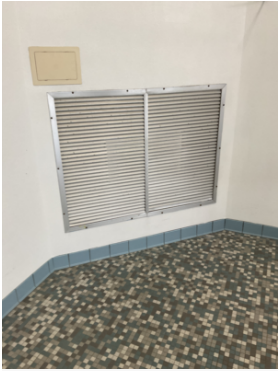
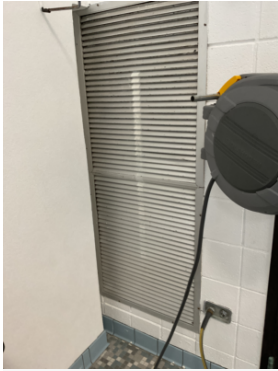
Low return/exhaust - Symon's Center

<p>July 1, 2025</p>	
Category: <i>! Mechanical</i>		Size:	
Type: <i>Grilles</i>		Installation Date:	
Manufacturer:		Observed Remaining Life: 5	
Model:		Condition: <i>Poor</i>	
Serial Number:		Cost:

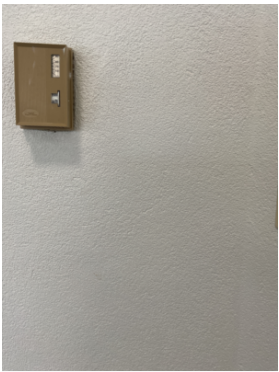
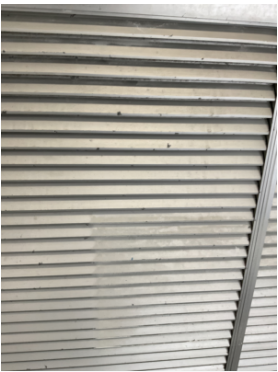
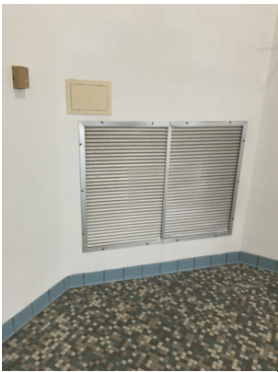
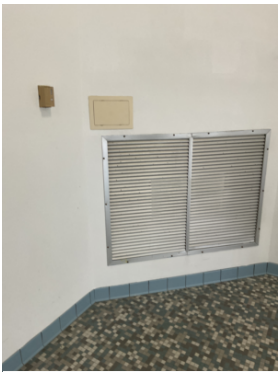
Low return/exhaust (4) - Symon's Center

<p>July 1, 2025</p>
Category: <i>! Mechanical</i>		Size:	
Type: <i>Grilles</i>		Installation Date:	
Manufacturer:		Observed Remaining Life: 8	
Model:		Condition: <i>Fair</i>	
Serial Number:		Cost:

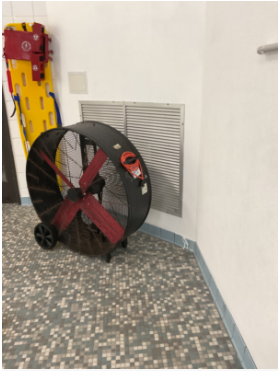
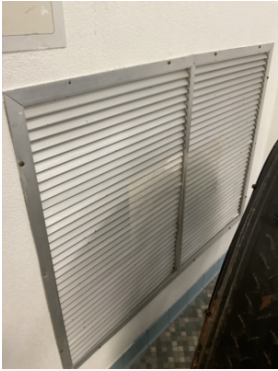
Low return/exhaust (5) - Symon's Center

<p>July 1, 2025</p>		
Category: <i>! Mechanical</i>		Size:	
Type: <i>Grilles</i>		Installation Date:	
Manufacturer:		Observed Remaining Life: <i>8</i>	
Model:		Condition: <i>Fair</i>	
Serial Number:		Cost:

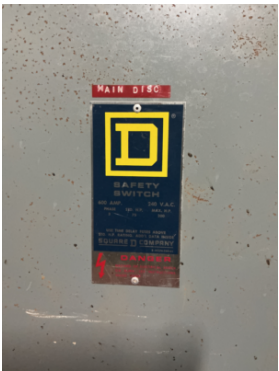
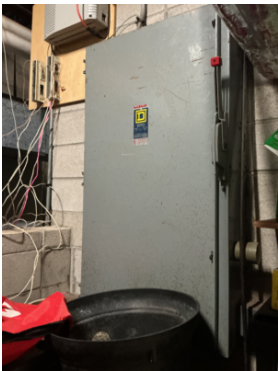
Main service disconnect - Symon's Center

The electrical distribution system installed within the Symon's Center Building terminates within a main disconnect which then feeds a fusible main distribution panel. This service is a 600A, 240/120V, single phase service that is also interfaced to a solar field located on site. This equipment is in fair-to-good condition. The branch panels installed throughout the building are Square-D NQOB style panels and are in fair condition. The degradation of these panels may be a function of the chlorinated air within this building that originates from the pool. This building is not provided with an emergency standby generator. Battery equipment is used to provide exit and egress lighting from the building.

<p>July 7, 2025</p>		
Category: <i>! Electrical</i>		Size:	
Type:		Installation Date:	
Manufacturer: <i>Square – D</i>		Observed Remaining Life: <i>10</i>	
Model:		Condition: <i>Fair</i>	
Serial Number:		Cost: <i>\$9809.02</i>

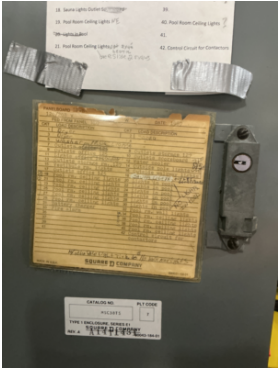
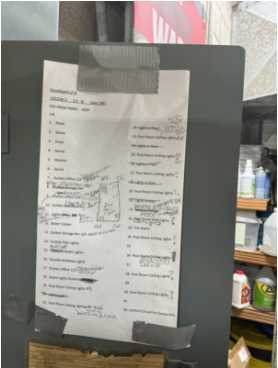
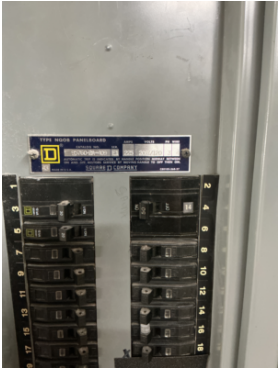
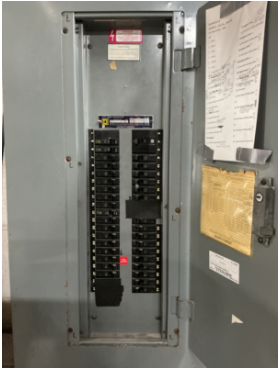
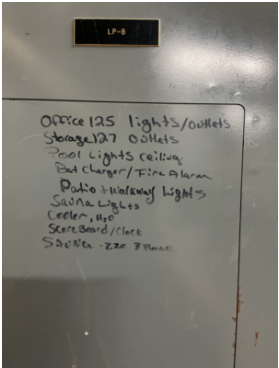
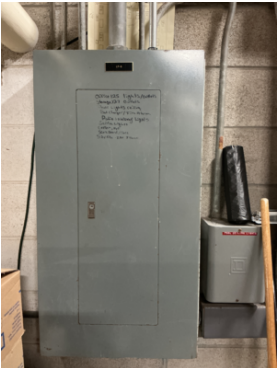
Panel LP – B - Symon's Center

<p>July 7, 2025</p>		
Category: ! Electrical		Size:	
Type:		Installation Date:	
Manufacturer: Square – D		Observed Remaining Life: 10	
Model:		Condition: Fair	
Serial Number:		Cost:

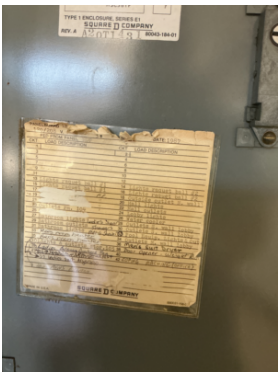
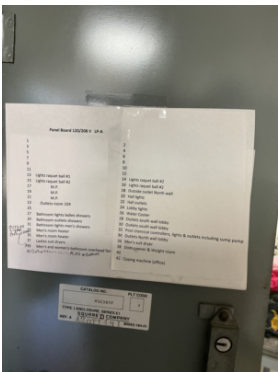
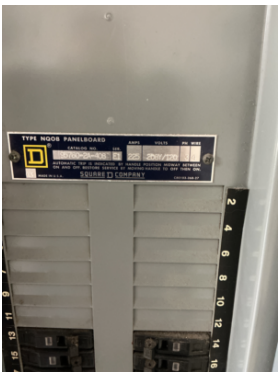
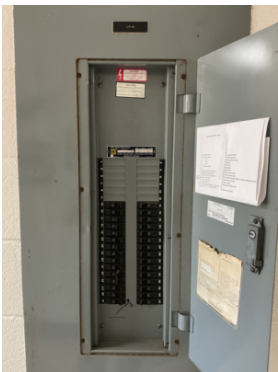
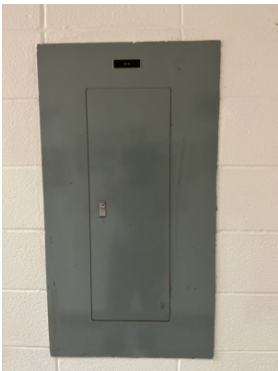
Panel LPA - Symon's Center

Category: <i>! Electrical</i>	Size:
Type:	Installation Date:
Manufacturer: <i>Square – D</i>	Observed Remaining Life: <i>10</i>
Model:	Condition: <i>Fair</i>
Serial Number:	Cost:

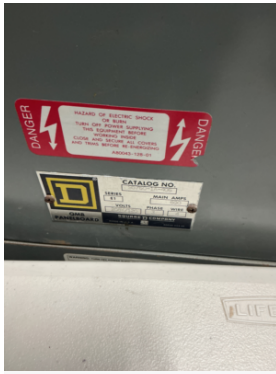
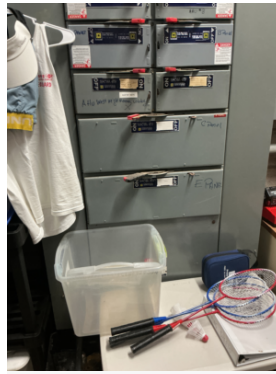
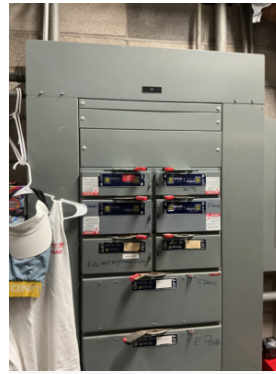
Panel MDP - Symon's Center

Category: ! *Electrical*

Observed Remaining Life: 15

Condition: *Good*

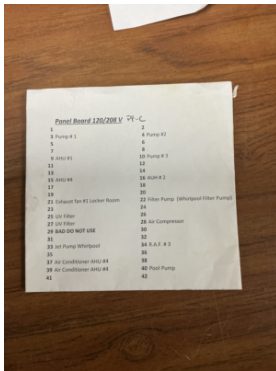
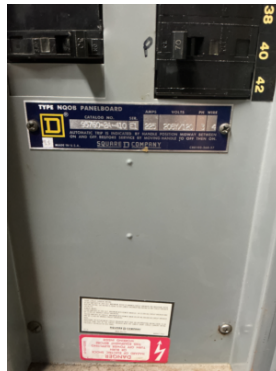
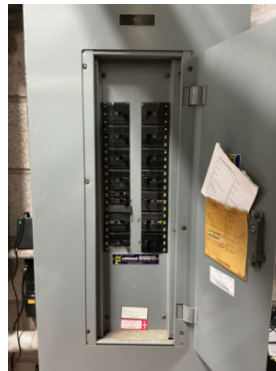
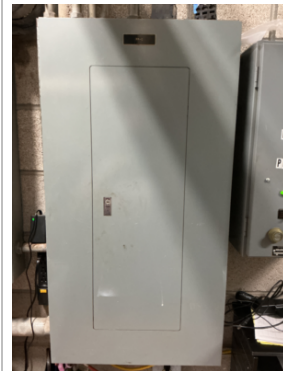
Panel PP – C - Symon's Center

Category: ! *Electrical*

Observed Remaining Life: 10

Condition: *Fair*

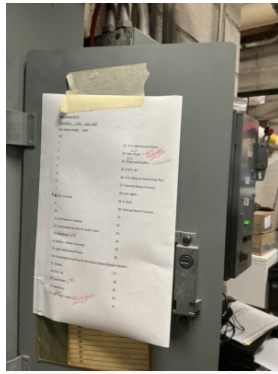
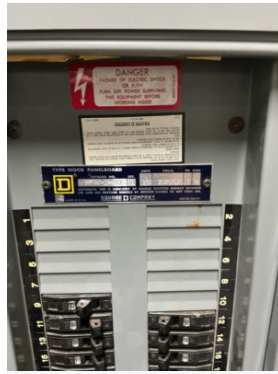
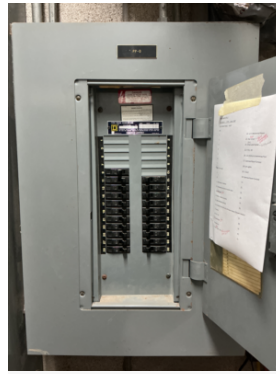
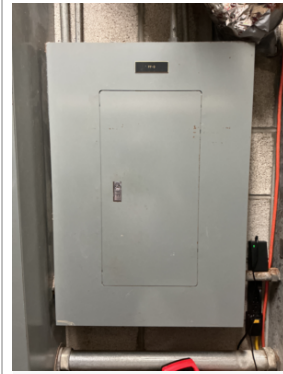
Panel PP – D - Symon's Center

Category: ! *Electrical*

Observed Remaining Life: *10*

Condition: *Fair*

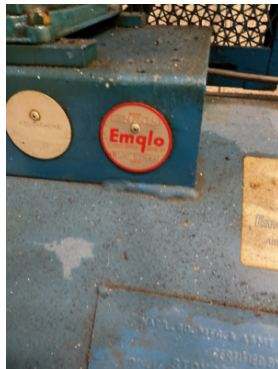
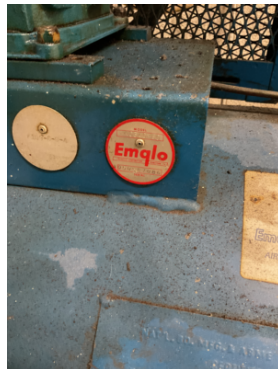
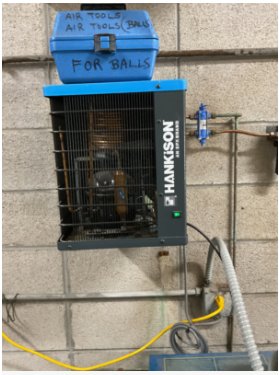
Pneumatic control compressor - Symon's Center

<p>July 1, 2025</p>		
Category: <i>! Mechanical</i>		Size:	
Type: <i>Compressor</i>		Installation Date:	
Manufacturer:		Observed Remaining Life: 5	
Model:		Condition: <i>Poor</i>	
Serial Number:		Cost: \$3810

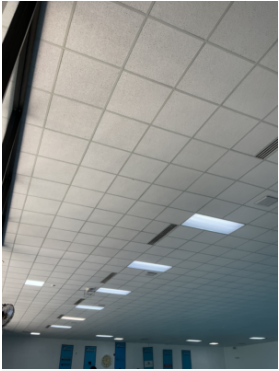
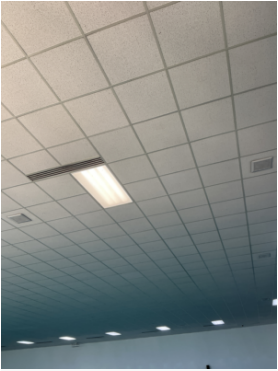
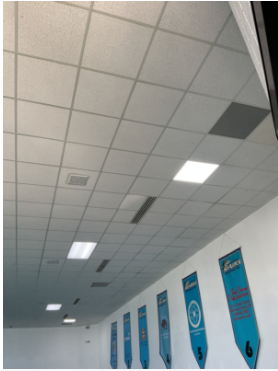
Pool lighting - Symon's Center

July 7, 2025	July 7, 2025	July 7, 2025	
Category: <i>! Electrical</i>		Size:	
Type:		Installation Date:	
Manufacturer:		Observed Remaining Life: 2	
Model:		Condition: <i>Good</i>	
Serial Number:		Cost:

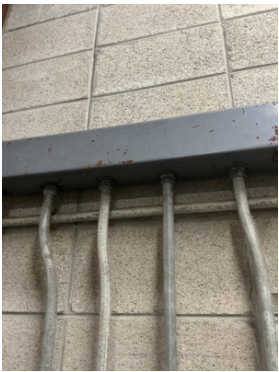
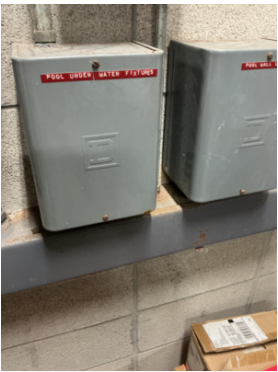
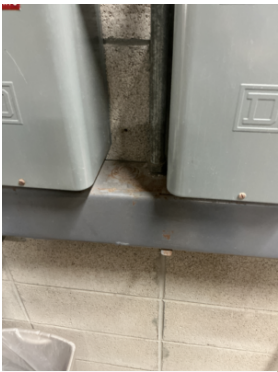
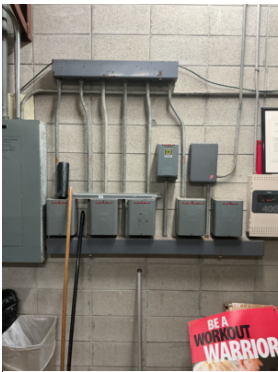
Pool lighting contractors - Symon's Center

July 7, 2025	July 7, 2025	July 7, 2025	July 7, 2025
Category: <i>! Electrical</i>		Size:	
Type:		Installation Date:	
Manufacturer: <i>Square – D</i>		Observed Remaining Life:	
Model:		Condition: <i>Fair</i>	
Serial Number:		Cost:

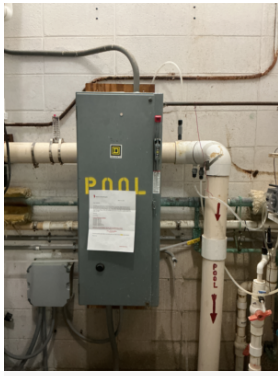
Pool main disconnect - Symon's Center

Category: ! *Electrical*

Observed Remaining Life: *15*

Condition: *Good*

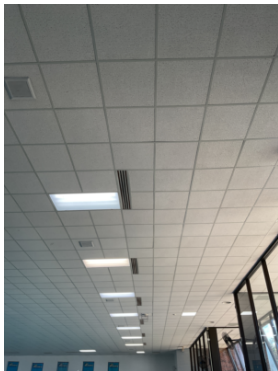
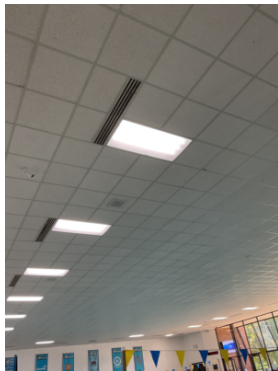
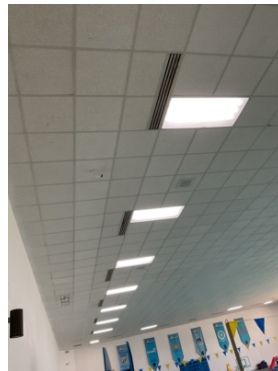
Pool supply air - Symon's Center

Observed Remaining Life: *10*

Condition: *Fair*

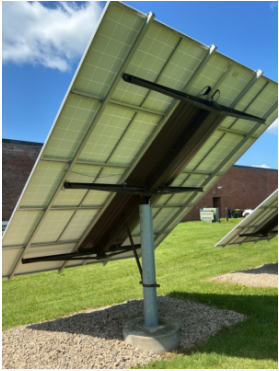
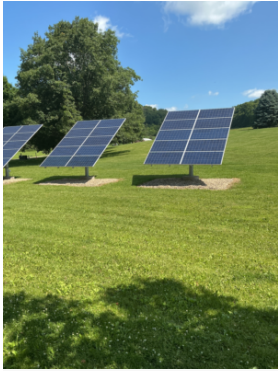
<u>Solar field</u> - <u>Symon's Center</u>

<p>July 7, 2025</p>	
Category: <i>! Electrical</i>		Size:	
Type:		Installation Date:	
Manufacturer:		Observed Remaining Life: <i>20</i>	
Model:		Condition: <i>Good</i>	
Serial Number:		Cost:

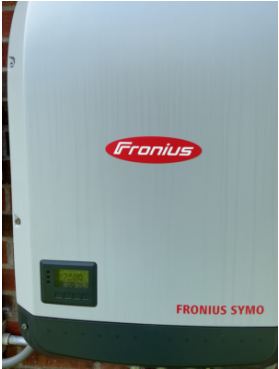
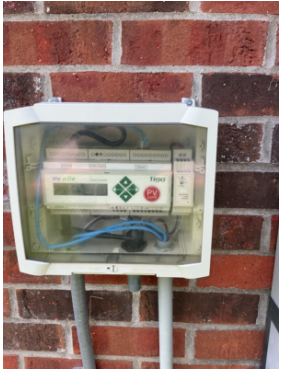
Solar field inverter - Symon's Center

<p>July 7, 2025</p>	  <p>July 7, 2025</p>	
Category: <i>! Electrical</i>		Size:	
Type:		Installation Date:	
Manufacturer: <i>Fronius</i>		Observed Remaining Life: <i>8</i>	
Model:		Condition: <i>Good</i>	
Serial Number:		Cost:

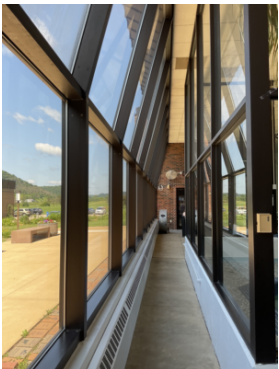
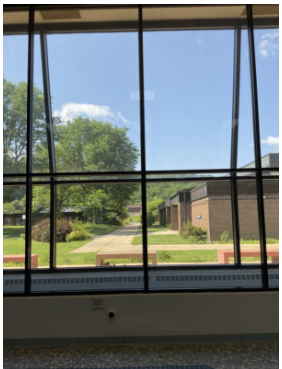
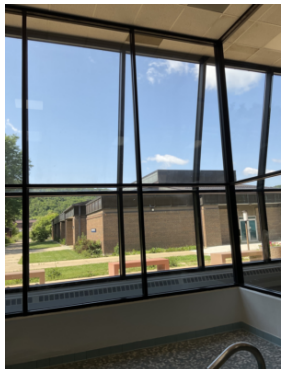
Storefront borrowed lights - Symon's Center

<p>July 21, 2025</p>
Category: <i>! Building Interior</i>		Size:	
Type: <i>Borrowed Lights</i>		Installation Date:	
Manufacturer:		Observed Remaining Life: <i>15</i>	
Model:		Condition: <i>Good</i>	
Serial Number:		Cost:

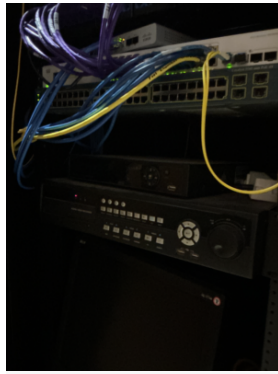
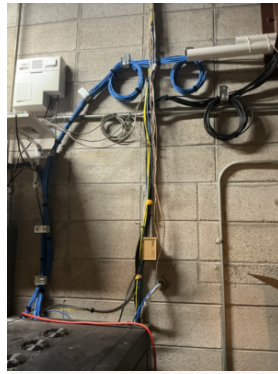
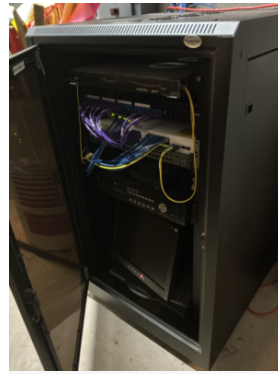
Telecom Distribution & DVR - Symon's Center

Category: ! Electrical

Observed Remaining Life: 10

Condition: Fair

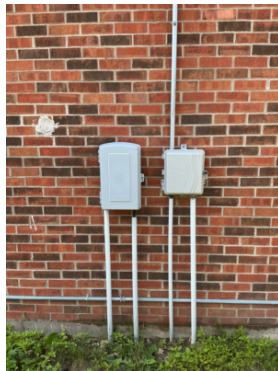
Telephone and fiber service entrance - Symon's Center

Category: ! Electrical

Observed Remaining Life: 15

Condition: Good

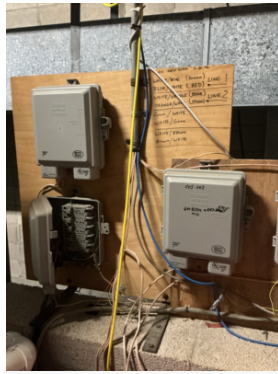
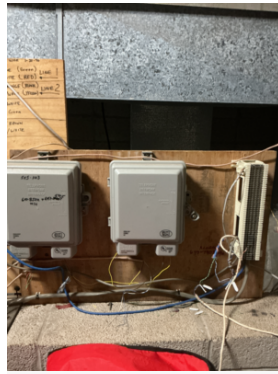
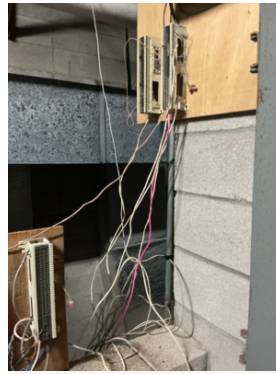
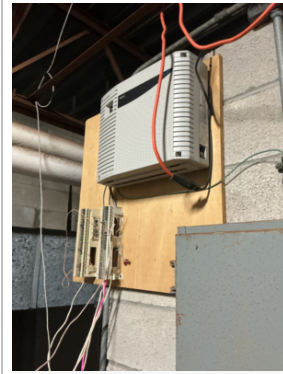
Telephone service entrance - Symon's Center

Category: ! Electrical

Observed Remaining Life: 3

Condition: Poor

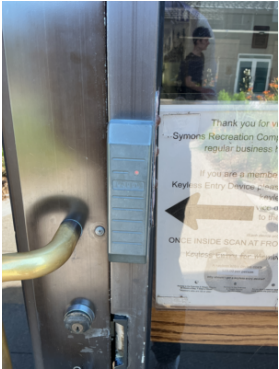
Typical card reader - [Symon's Center](#)

<p>July 7, 2025</p>			
Category: <i>! Electrical</i>	Size:		
Type:	Installation Date:		
Manufacturer: <i>HID</i>	Observed Remaining Life: <i>5</i>		
Model:	Condition: <i>Fair</i>		
Serial Number:	Cost:

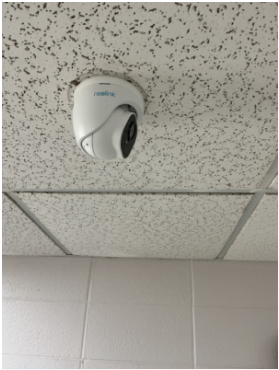
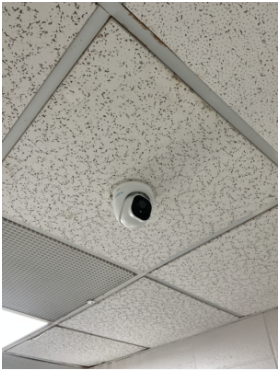
Typical CCTV camera - [Symon's Center](#)

<p>July 7, 2025</p>		
Category: <i>! Electrical</i>	Size:		
Type:	Installation Date:		
Manufacturer:	Observed Remaining Life: <i>5</i>		
Model:	Condition: <i>Good</i>		
Serial Number:	Cost:

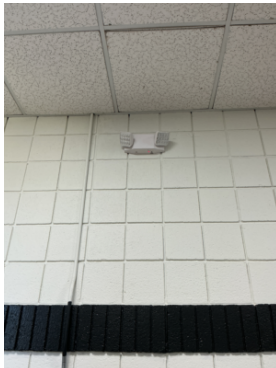
Typical emergency battery unit - [Symon's Center](#)

Category: ! Electrical	Size:
Type:	Installation Date:
Manufacturer:	Observed Remaining Life: 8
Model:	Condition: Good
Serial Number:	Cost:

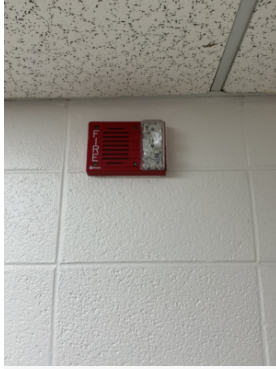
Typical fire alarm annunciation device - Symon's Center

Category: ! Electrical

Observed Remaining Life: 15

Condition: Good

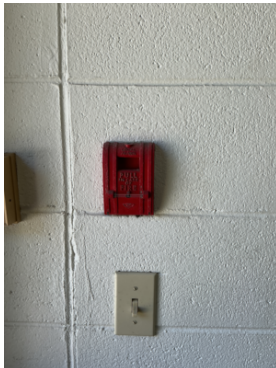
Typical fire alarm pull station - Symon's Center

Category: ! Electrical

Observed Remaining Life: 8

Condition: Fair

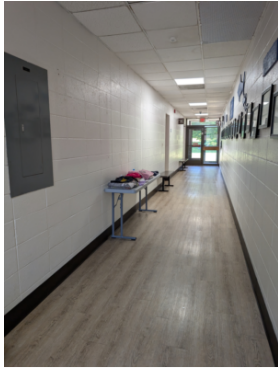
Typical hallway flooring - [Symon's Center](#)

Category: ! Building Interior

Observed Remaining Life: 15

Condition: Good

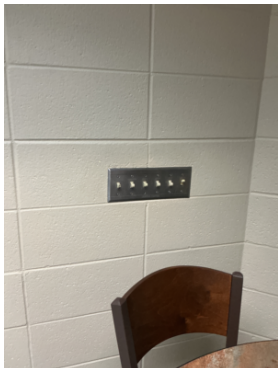
Typical lighting control controls - [Symon's Center](#)

Category: ! Electrical

Observed Remaining Life: 15

Condition: Good

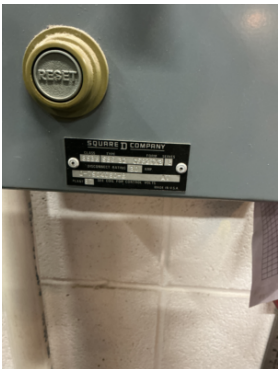
Typical motor starter - [Symon's Center](#)

<p>July 7, 2025</p>		
Category: <i>! Electrical</i>	Size:		
Type:	Installation Date:		
Manufacturer: <i>Square – D</i>	Observed Remaining Life: <i>8</i>		
Model:	Condition: <i>Fair</i>		
Serial Number:	Cost:

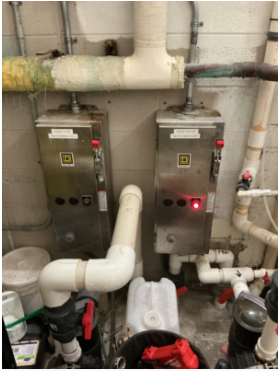
Typical pool pump disconnect - [Symon's Center](#)

<p>July 7, 2025</p>			
Category: <i>! Electrical</i>	Size:		
Type:	Installation Date:		
Manufacturer: <i>Square – D</i>	Observed Remaining Life: <i>8</i>		
Model:	Condition: <i>Fair</i>		
Serial Number:	Cost:

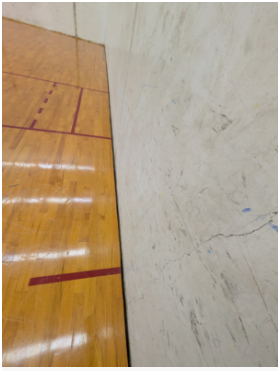
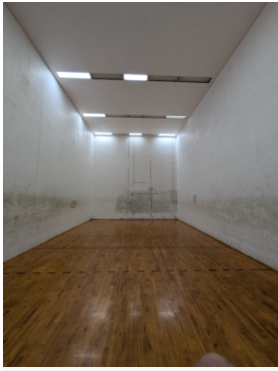
Typical Racquetball Court Flooring - [Symon's Center](#)

The racquetball courts are in very poor condition. There is major cracking present throughout the plaster of all the walls in both racquetball courts, all the plaster in both courts will require a refinish or complete replacement. Both courts have noticeable gaps between the floor and walls that are called expansion voids which are necessary to allow movement within the flooring system. We recommend installing a vent cove base to the walls to properly address these expansion voids (gaps) at both courts. Additionally, the lighting is poor and some of the fluorescent light bulbs have reached the end of their useful life. They will also require replacement; some consideration should be given to completely replacing them with LED fixtures in the future.

<p>October 22, 2025</p>	
Category: <i>! Building Interior</i>	Size:		
Type:	Installation Date:		
Manufacturer:	Observed Remaining Life: <i>5</i>		
Model:	Condition: <i>Poor</i>		
Serial Number:	Cost: <i>\$1080</i>

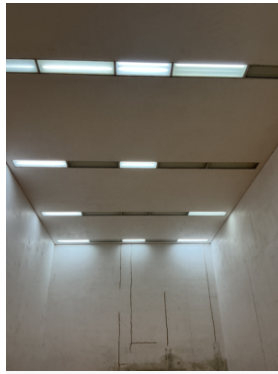
Typical racquetball lighting system - Symon's Center

Category: ! *Electrical*

Observed Remaining Life: 2

Condition: *Poor*
