NOTICE OF MEETING

Facility Condition Assessment Dashboard

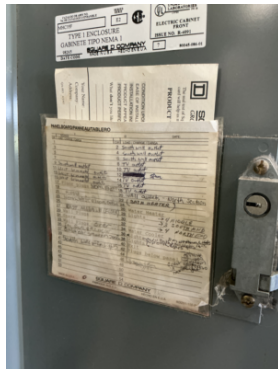
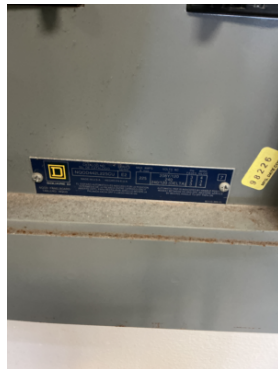
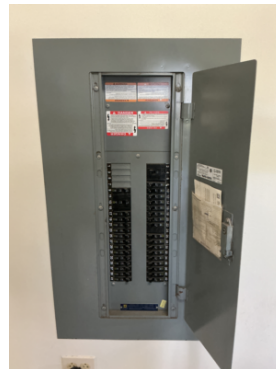
Unnamed panel - Symon's Center

Category: ! *Electrical*

Observed Remaining Life: 15

Condition: *Good*

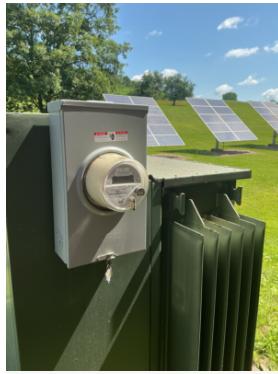
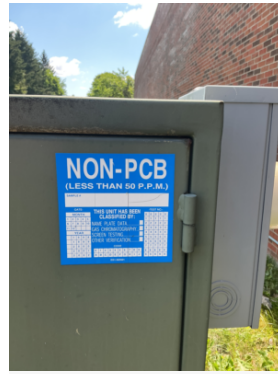
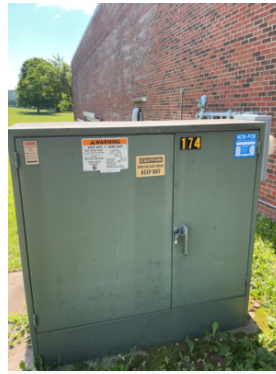
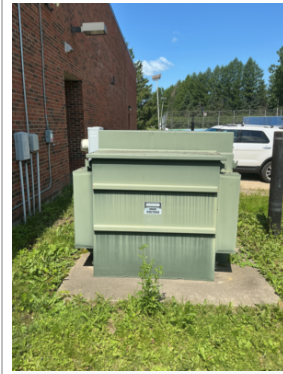
Utility transformer - Symon's Center

Category: ! *Electrical*

Observed Remaining Life: 15

Condition: *Good*

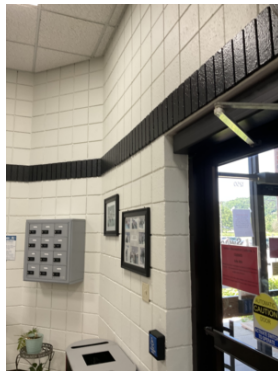
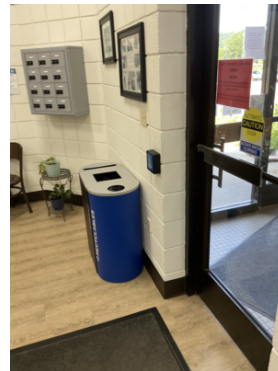
Vestibule Door - Symon's Center

Category: ! *Building Interior*

Observed Remaining Life: 10

Condition: *Good*

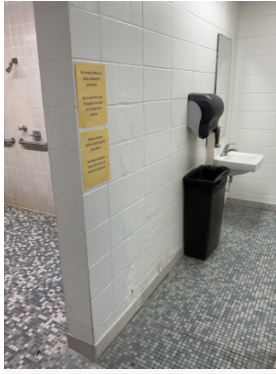
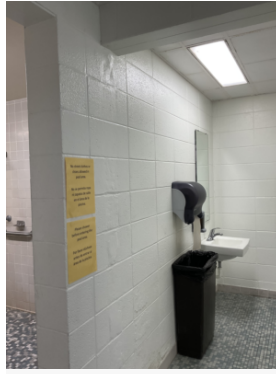
Wall - Symon's Center

Category: ! Building Interior

Observed Remaining Life: 5

Condition: Fair

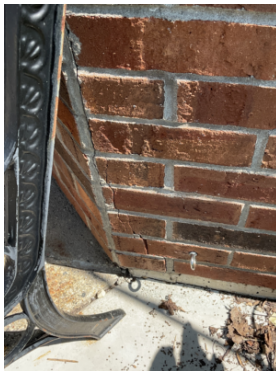
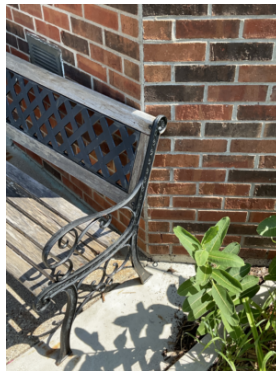
Wall - Symon's Center

Category: ! Building Exterior

Observed Remaining Life: 10

Condition: Good

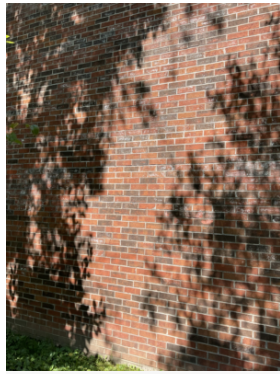
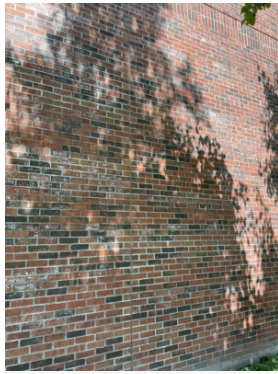
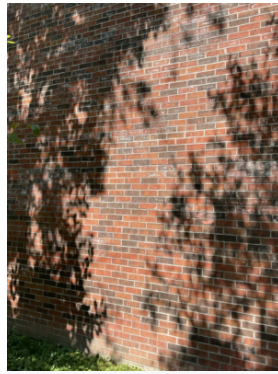
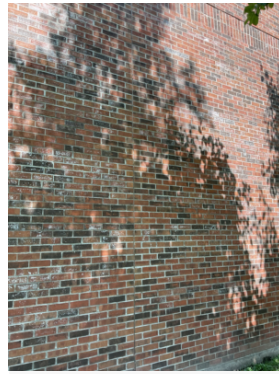
Wall - Symon's Center

Category: ! Building Exterior

Observed Remaining Life: 3

Condition: Fair

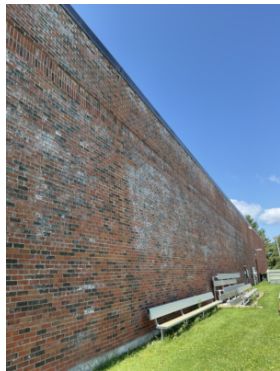
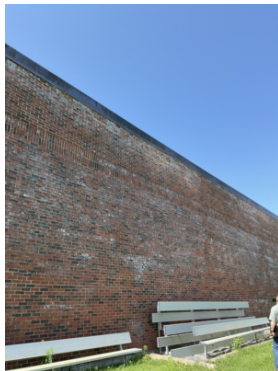
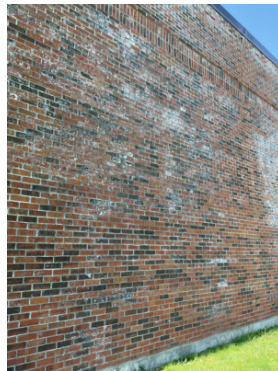
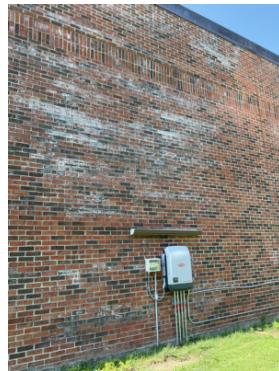
Wall - Symon's Center

Category: ! Building Exterior

Observed Remaining Life: 2

Condition: Poor

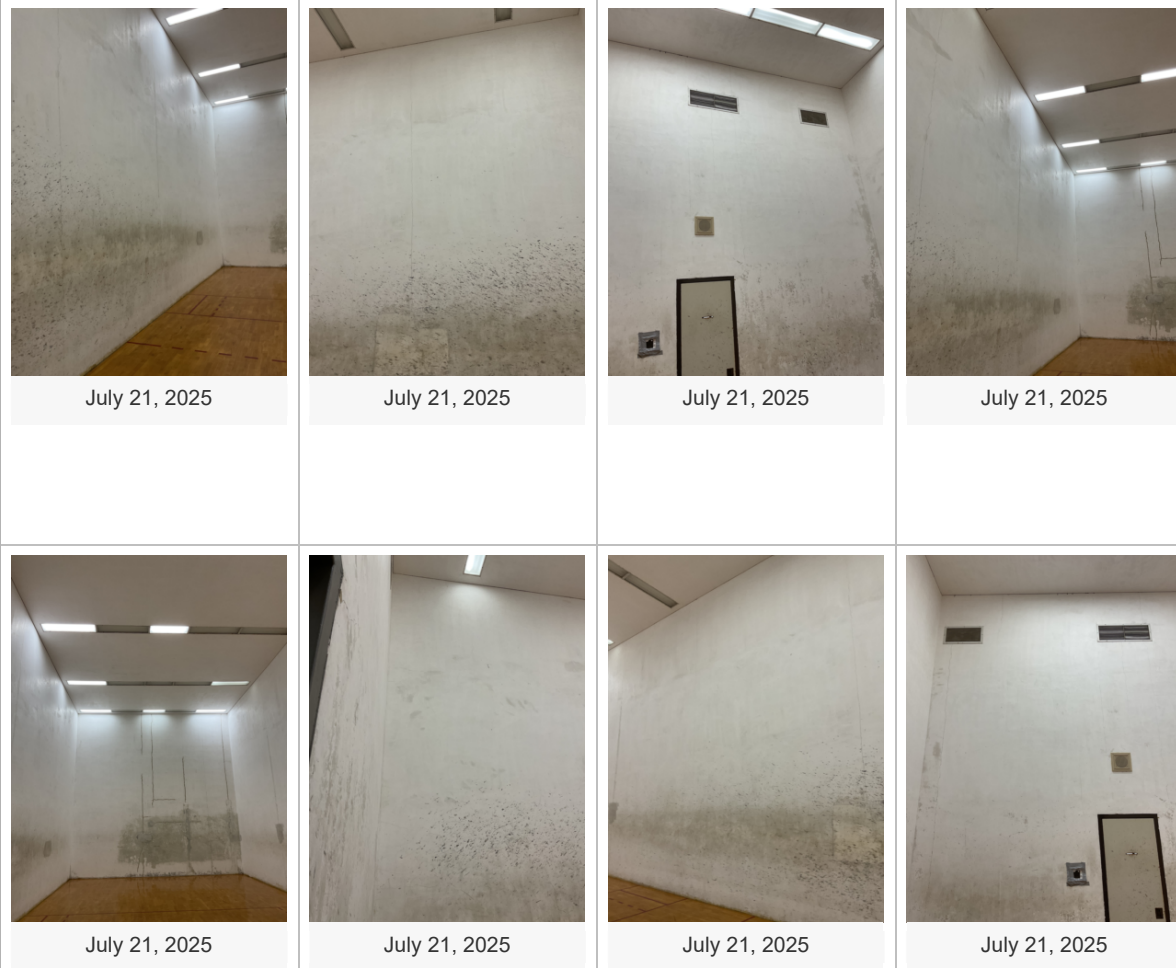
Walls - Symon's Center

Category: *! Building Interior*

Observed Remaining Life: 2

Condition: *Very Poor*

Cost: \$3124.35

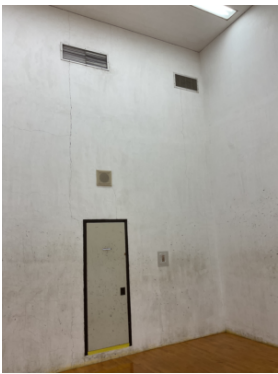
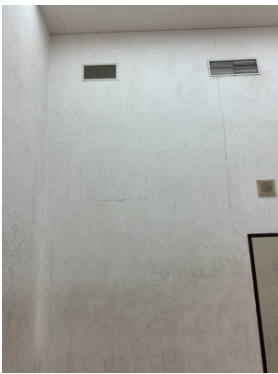
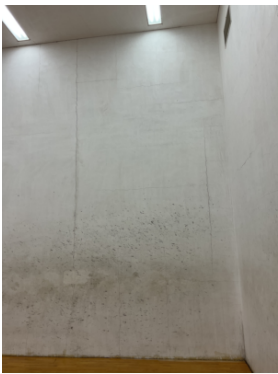
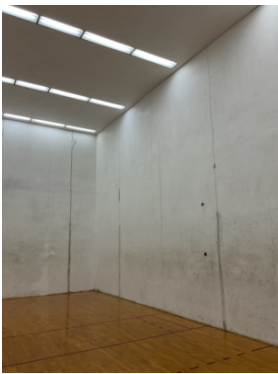
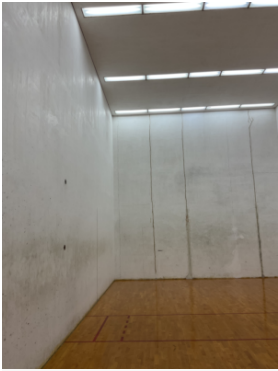
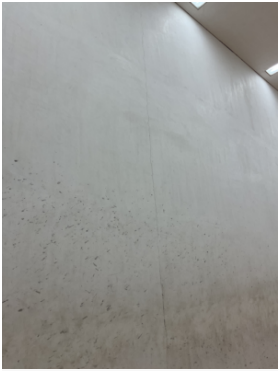
Walls - Symon's Center

Category: *! Building Interior*

Observed Remaining Life: *2*

Condition: *Very Poor*

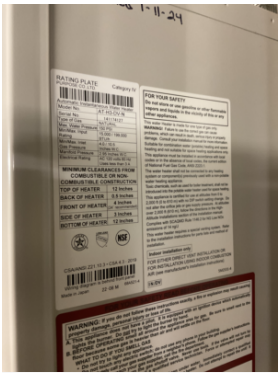
Water heaters - Symon's Center

<p>July 1, 2025</p>	<p>July 1, 2025</p>		
Category: <i>! Plumbing</i>		Size:	
Type: <i>Water Heater</i>		Installation Date:	
Manufacturer:		Observed Remaining Life: 7	
Model:		Condition: <i>Good</i>	
Serial Number:		Cost:

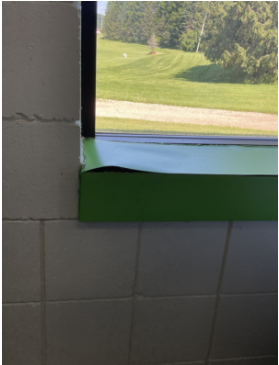
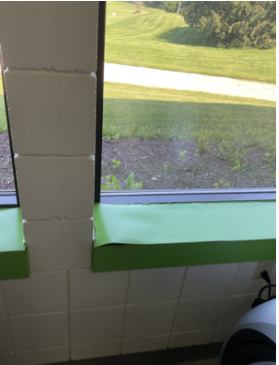
<u>Window</u> - <u>Symon's Center</u>

July 21, 2025	July 21, 2025	July 17, 2025	
Category: ! Building Exterior		Size:	
Type:		Installation Date:	
Manufacturer:		Observed Remaining Life: 3	
Model:		Condition: Fair	
Serial Number:		Cost:

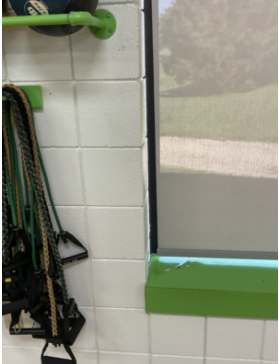
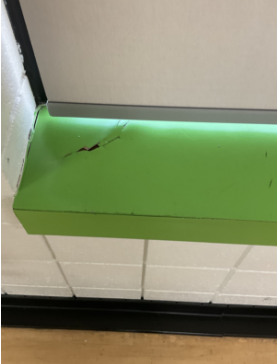
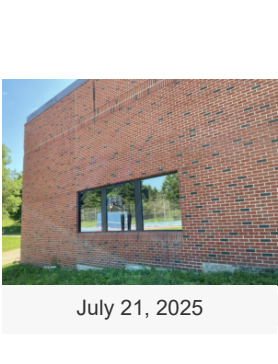
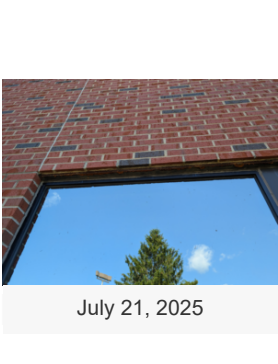
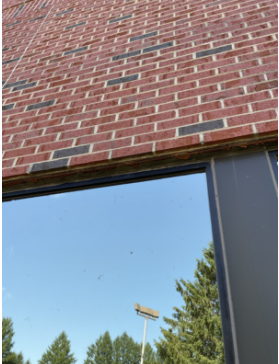
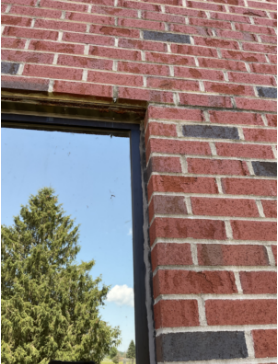
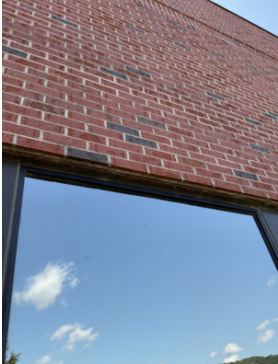
Window - Symon's Center

Category: ! Building Exterior	Size:
Type:	Installation Date:
Manufacturer:	Observed Remaining Life: 3
Model:	Condition: Fair
Serial Number:	Cost:

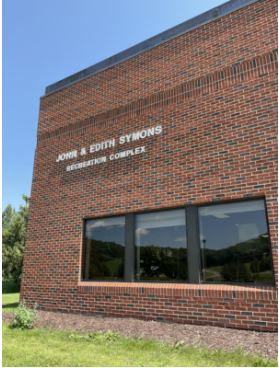
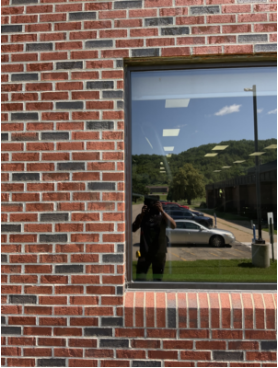
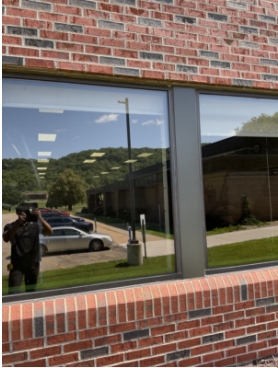
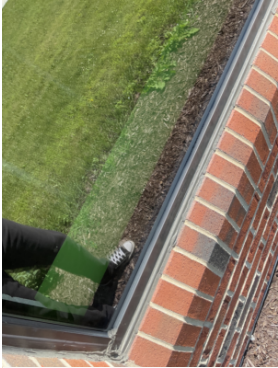
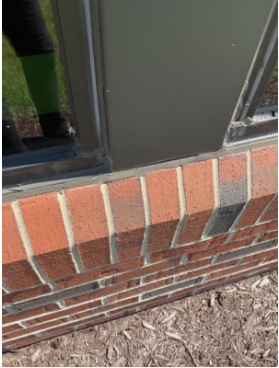
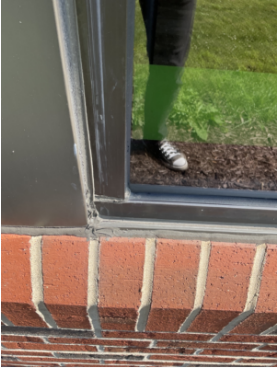
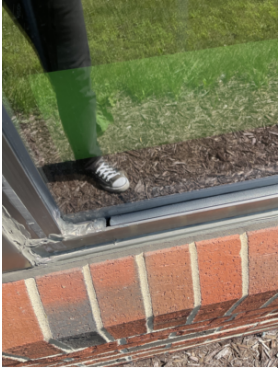
Window - **Symon's Center**

Category: ! Building Exterior	Size:
Type:	Installation Date:
Manufacturer:	Observed Remaining Life: 3
Model:	Condition: Fair
Serial Number:	Cost:

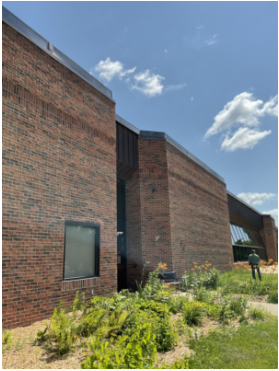
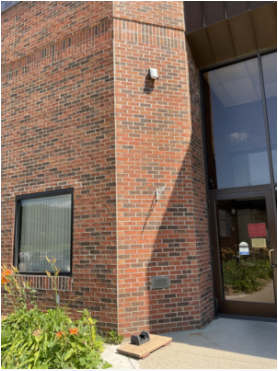
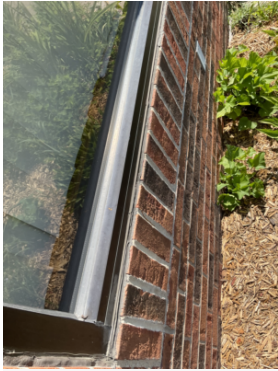
Window - Symon's Center

<p>July 17, 2025</p>	
Category: <i>! Building Exterior</i>		Size:	
Type:		Installation Date:	
Manufacturer:		Observed Remaining Life: 3	
Model:		Condition: <i>Good</i>	
Serial Number:		Cost:

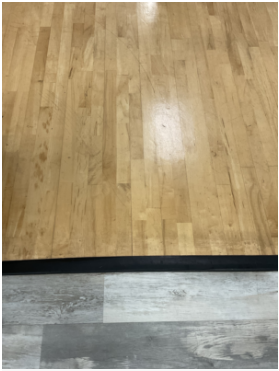
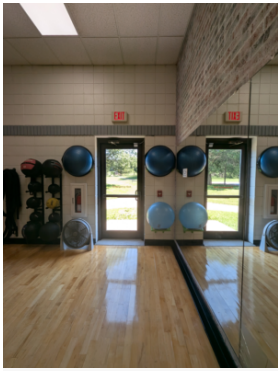
Wood flooring - Symon's Center

<p>July 21, 2025</p>	
Category: <i>! Building Interior</i>		Size:	
Type: <i>Floor Finishes</i>		Installation Date:	
Manufacturer:		Observed Remaining Life: 10	
Model:		Condition: <i>Fair</i>	
Serial Number:		Cost:
